## WATERSHED-BASED PLAN

### East Branch North River

August 2021

Massachusetts Association of Conservation Districts  
Geosyntec Consultants, Inc.

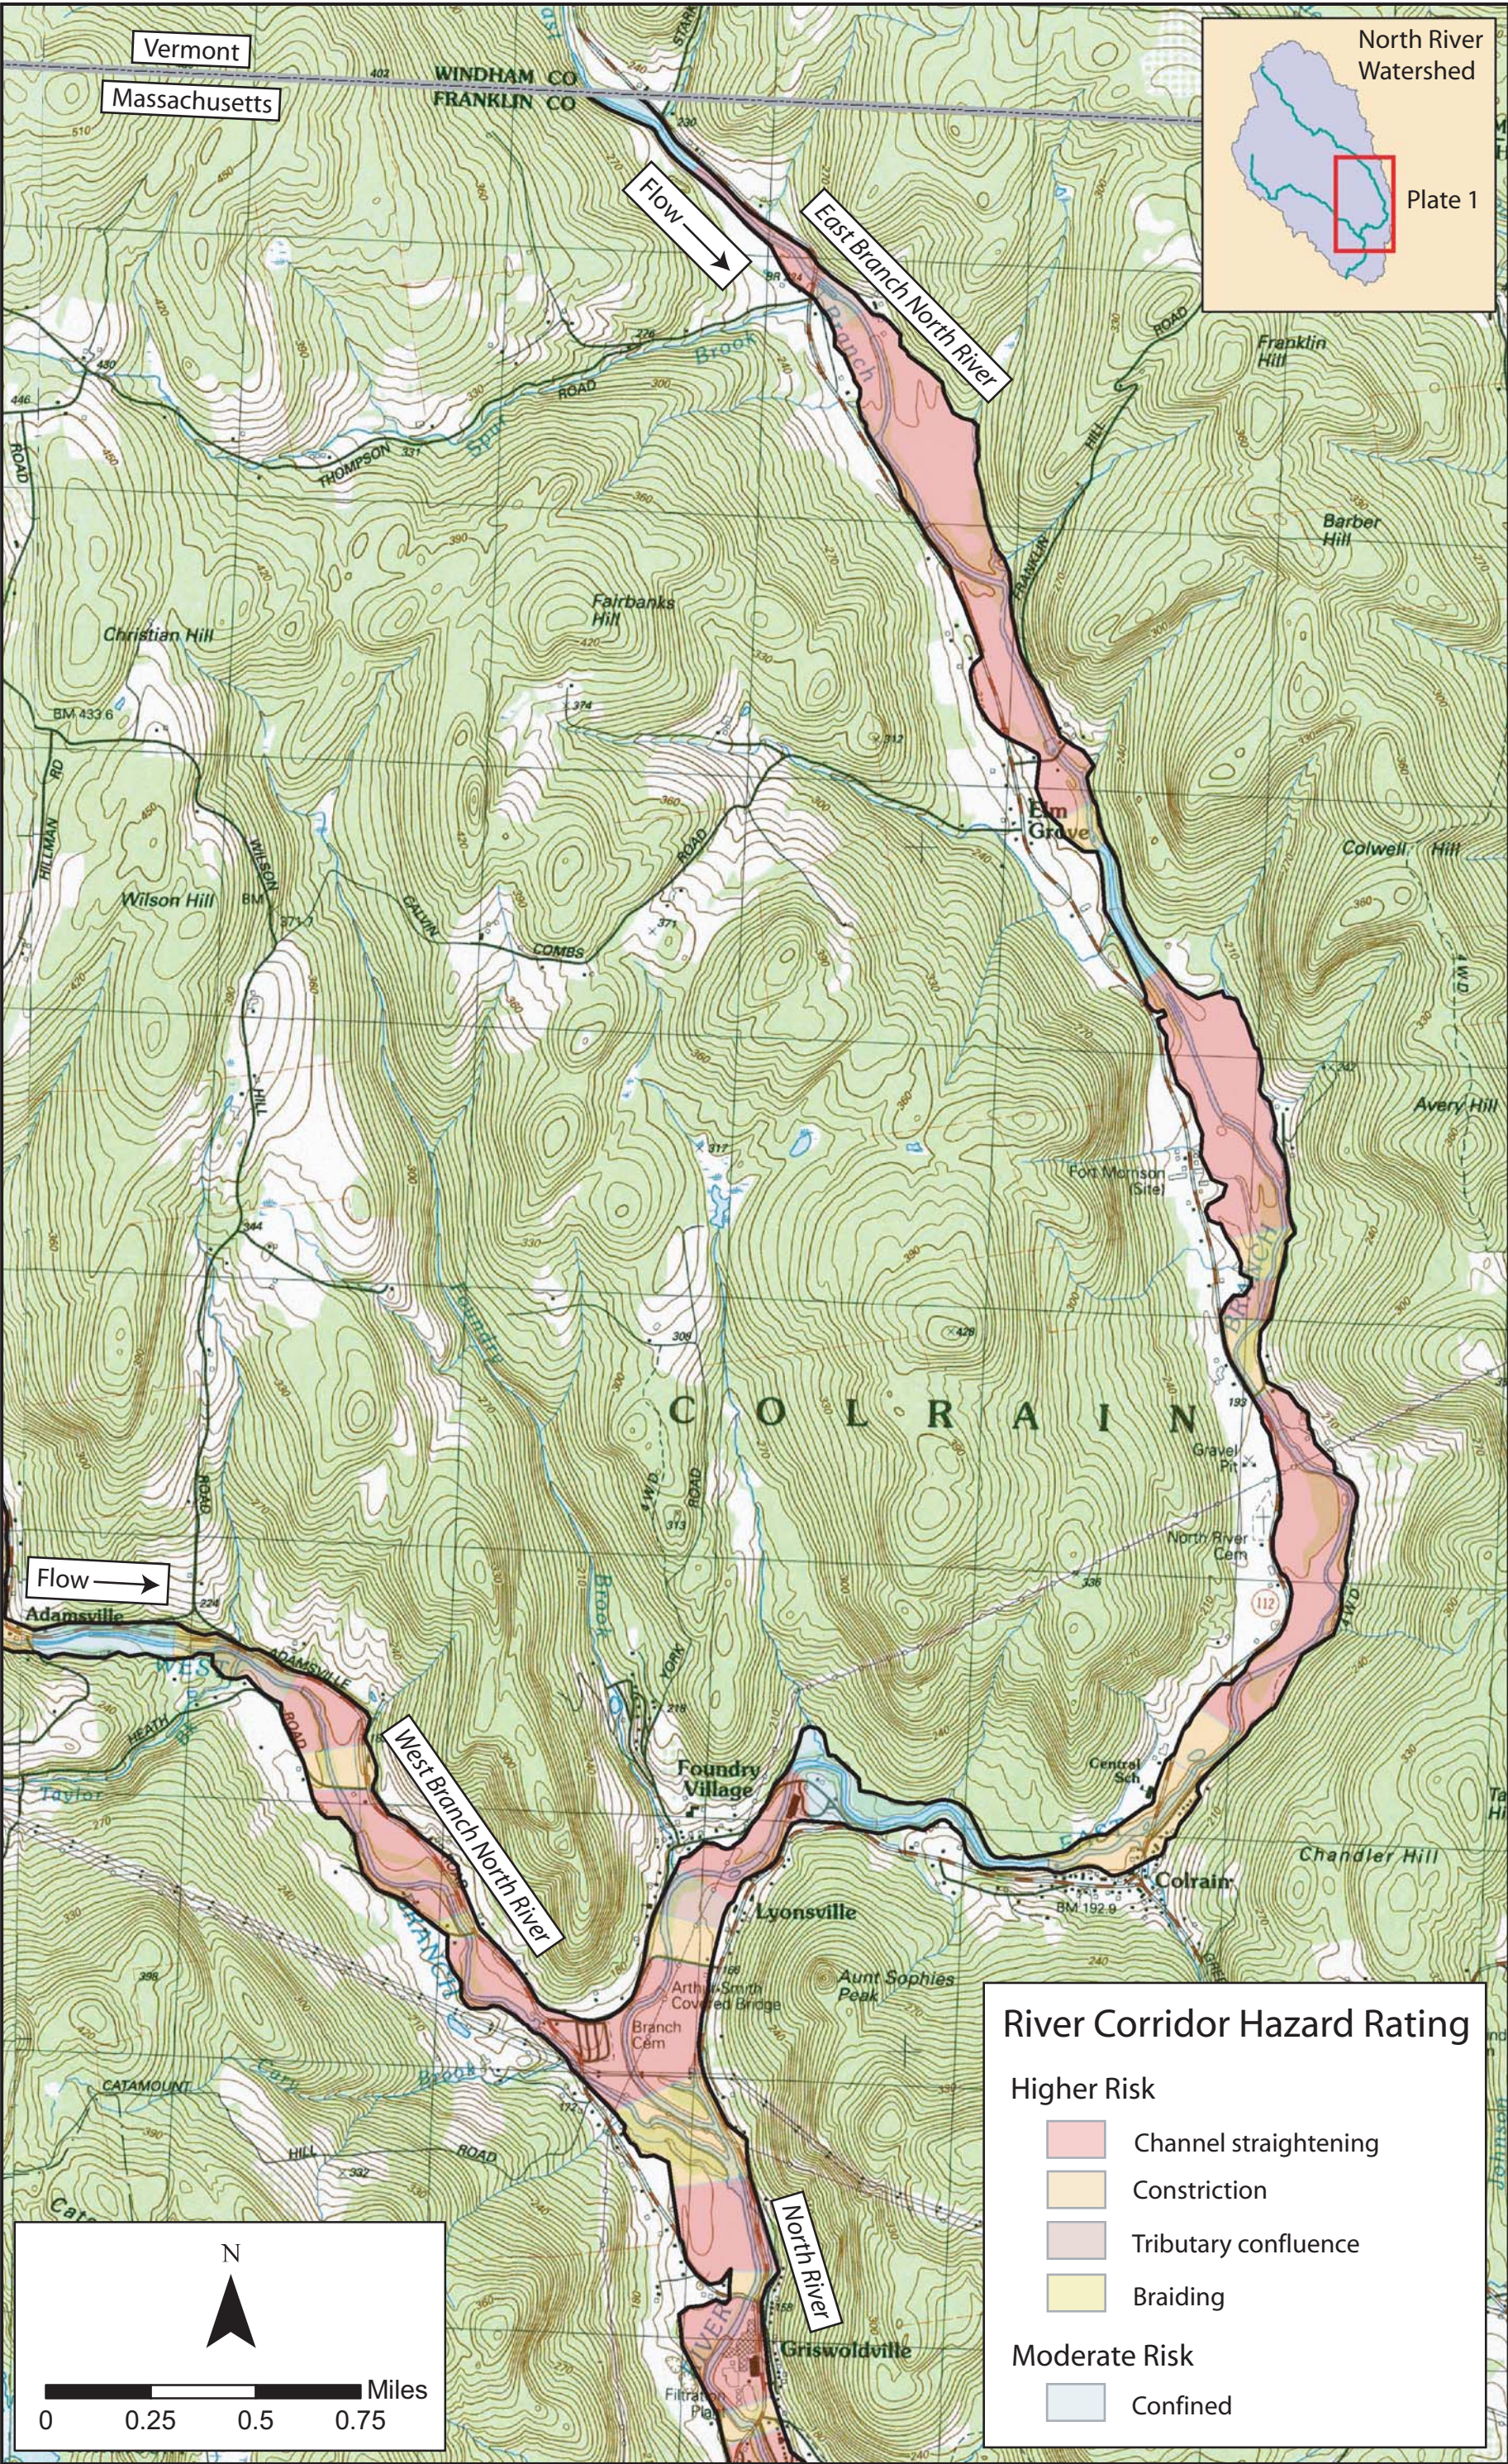
River Corridor Map - Topographic map (USGS) - Plate 1 of 3.

A report was developed in 2018, which describes the development of a river corridor mapping protocol based on the science of fluvial geomorphology that will allow riverine communities in Massachusetts to relatively easily and inexpensively delineate areas prone to flood and erosion hazards. The North River Watershed was used to test the methodology and compare the results with other geomorphic assessments recently completed in the watershed. For the study, river corridor was defined as “the area of the valley bottom and floodplain across which the river migrates over time in order to develop and sustain an equilibrium condition where changes in the channel’s dimensions, planform, and gradient are minimized”. The report concluded that compared to other geomorphic assessment methods that are available, the river corridor mapping protocol presented in the report was more effective at identifying the location and severity of erosion hazards and channel migration that are responsible for the most severe damages during storms like Tropical Storm Irene. The corridor mapping procedures were developed for use by conservation districts, towns, and other organizations working to better plan and prepare for future floods. The assessment found that the entire East Branch North River corridor is designated as moderate or higher risk due to the confined areas, valley constrictions, and artificially straightened reaches. The resulting East Branch North River Corridor Map is included in **Appendix C**.
