## WATERSHED-BASED PLAN

Farm Pond (AU ID# MA72039)

Updated July 30, 2026

Applied Watershed Sciences LLC

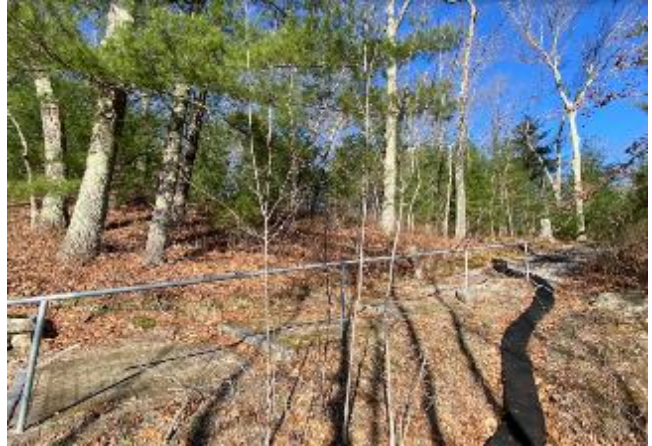
***Town-installed pervious stairs to reduce runoff, with additional erosion control and water routing coir logs.***

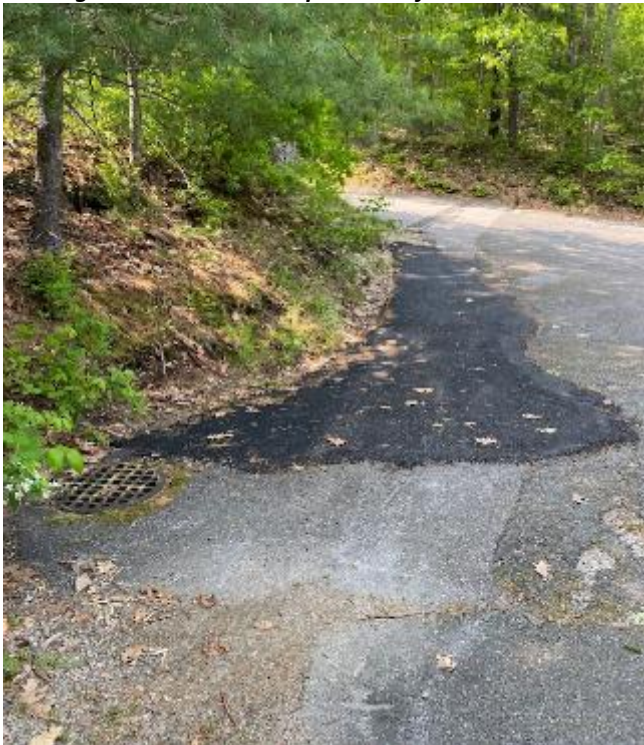
***Existing trench drain and repairs to infiltration basin***

The Town of Sherborn has an existing trench drain that captures a large portion of the runoff from the boat ramp zone, funneling water to a series of small containment and infiltration sumps. The Town is also aware of runoff from the footpath and steps that lead from the parking area to the Town beach; seasonal coir logs have been placed in multiple areas that route runoff from these areas into the woods, where infiltration of smaller rain events has been successful. The Town has installed pervious materials to reduce runoff from the stairs and foot path, and has also used erosion control methods along the beach area, minimizing beach sand erosion from the most frequent smaller storms. Larger storms still cause erosion, depending on activities and active construction project timelines, as evidenced by volunteer-collected runoff samples on Town property. The mechanisms currently in place have largely succeeded in minimizing erosion from small to moderate storms. The beach erosion that occurs is a combination of groundwater eruption from the hillside and surface runoff from larger storms. Several photos of existing conditions are provided here.

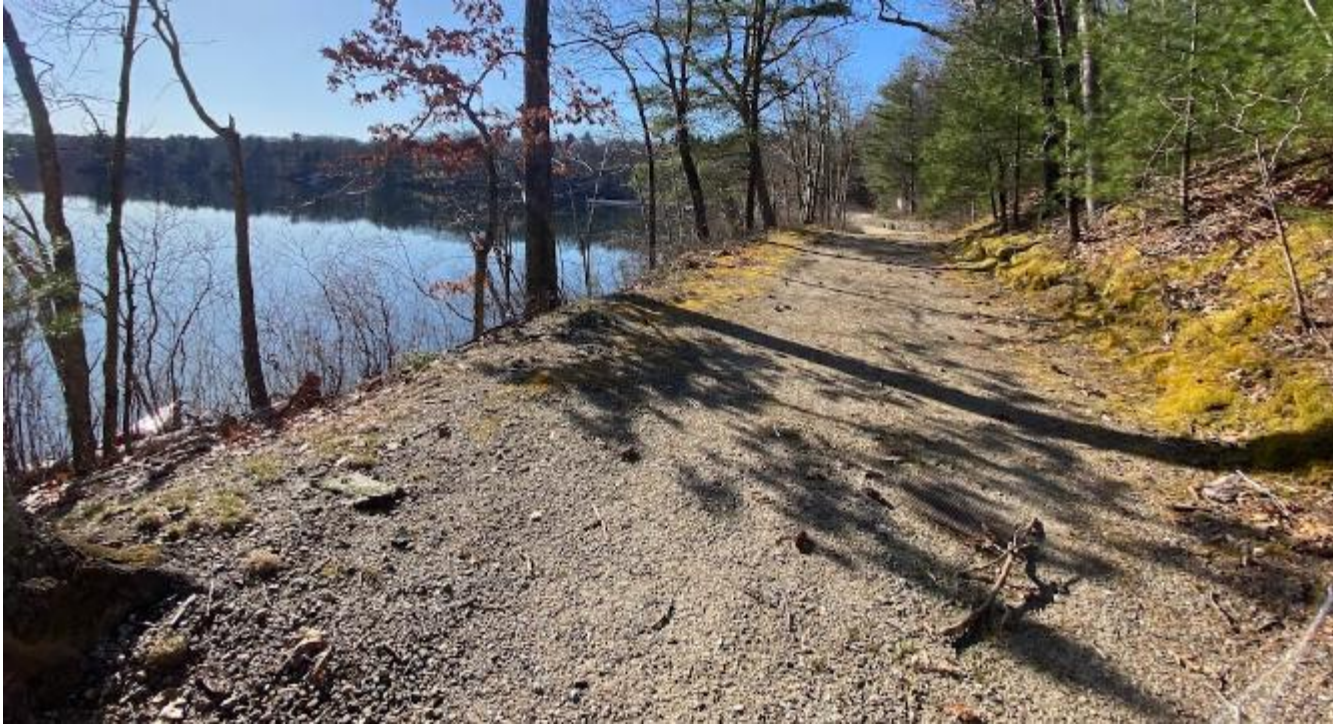
***The Town's foot path from the boat ramp to the beach is sloped slightly away from the lake to minimize direct runoff and erosion. Emergency vehicles only. Naturally vegetated hillside. No major erosion issues present at this time.***

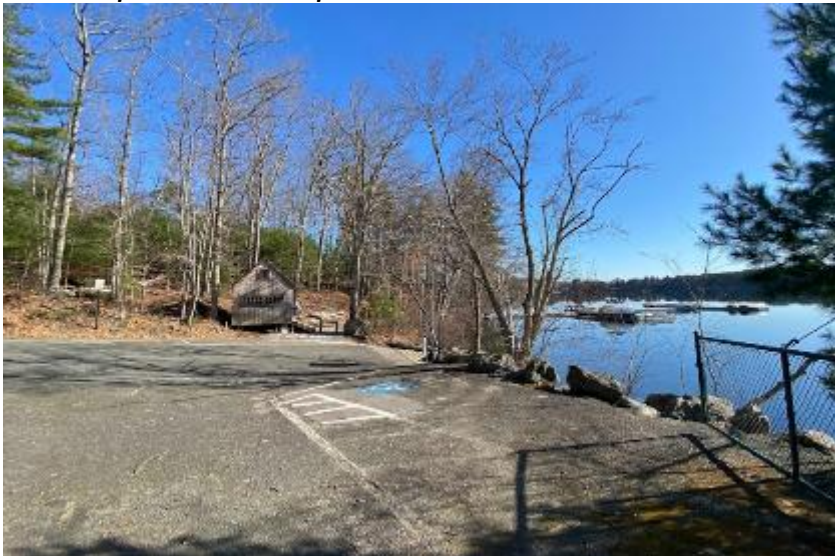
***Relatively low-sloped boat ramp staging area minimizes erosion by design. Further improvements anticipated.***

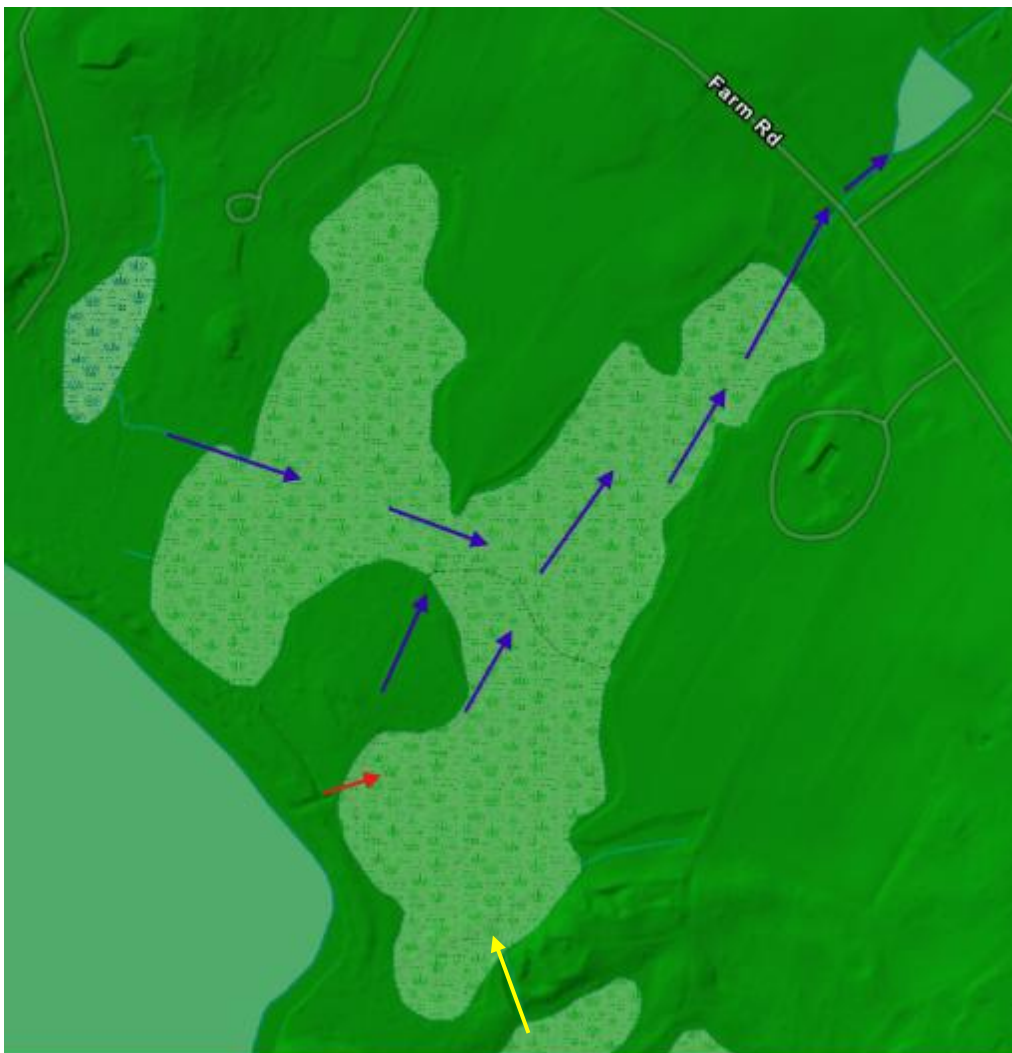
***Map 3. Farm Pond outlet flows (groundwater and surface water)***

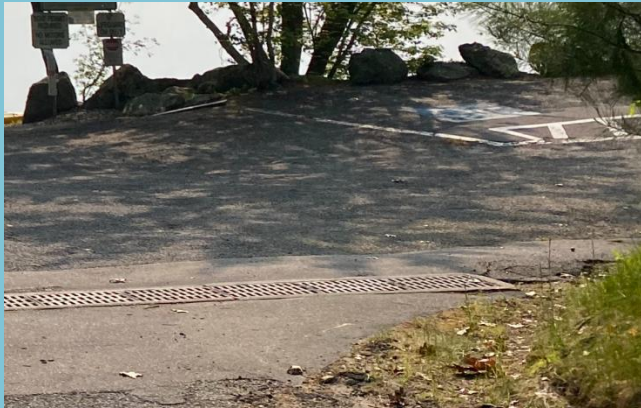
| | <p>The existing trench drain does not receive all of the stormwater runoff from upslope. Water is undercutting the existing drain in a few places and is also flowing around the drain corner, where repairs have been made, and an infiltration drywell exists.</p> |

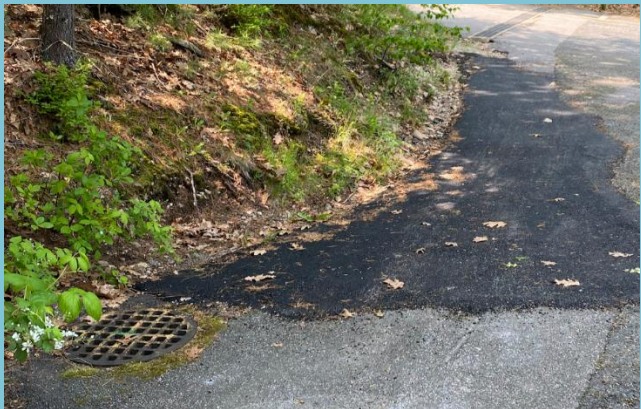
| | <p>The existing drywell appears to be working, but during heavy rain, the amount of water that flows to this location overshoots these drains and continues to stream as overland flow to the lake. If this repaved area is turned into a vegetated swale prior to the drywell, it would better capture higher volume runoff.</p> <p>There is also room for a potential drywell or swale at the top of the hill (third image) to reduce water volume downslope. This site should be addressed if the Town proceeds with further improvements to the parking lot and pavement, which is eroded and crumbling from general age and use.</p> |

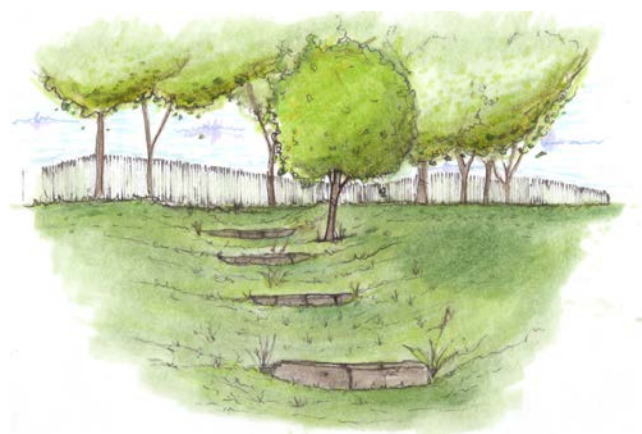
Figure 2. Check dams within a swale slow the flow, allowing sediments to settle out and some infiltration to occur.
