## WATERSHED-BASED PLAN

Lake Massapoag (MA73030)

2026-2050

Sharon, Massachusetts

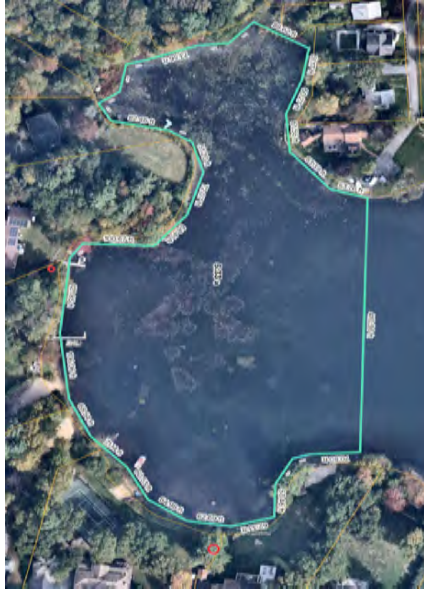
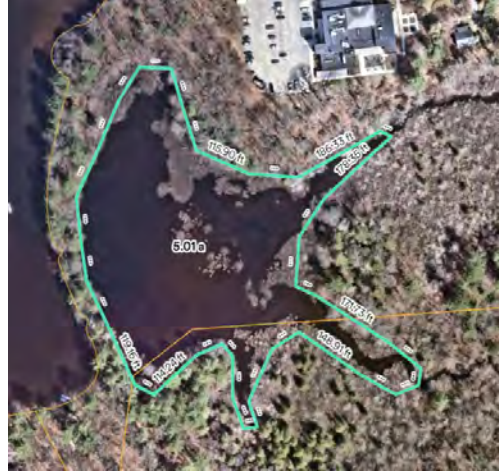
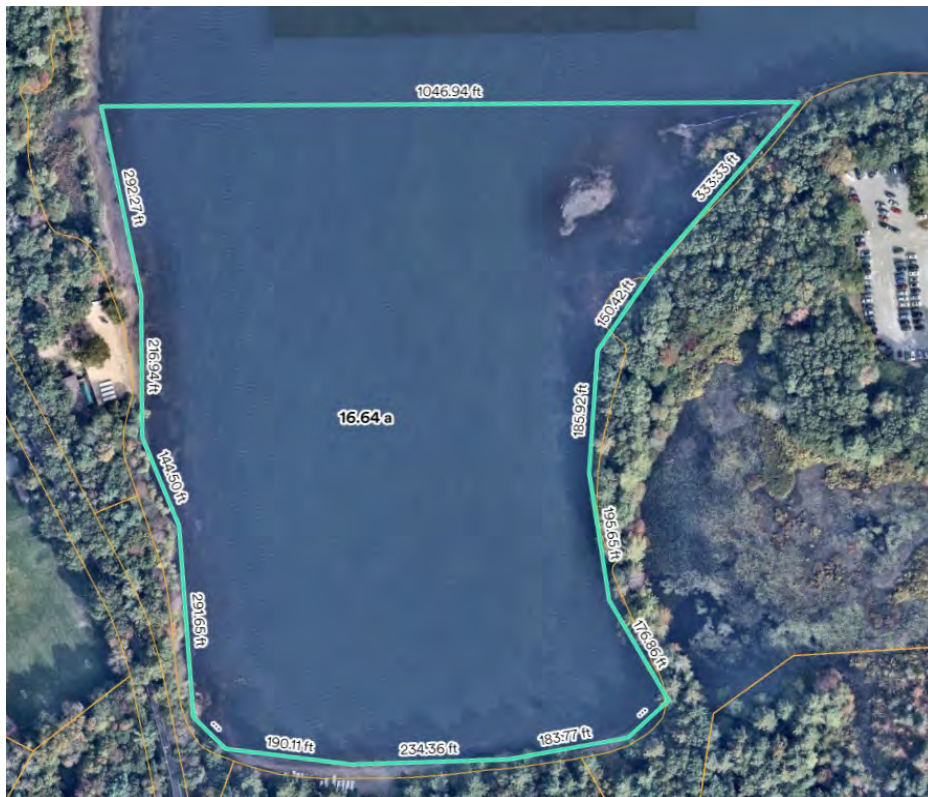
**LMAC Figure BG-3: Lake Massapoag Coves and Lagoon**

*Top Left: Fletcher's Cove, Top Right: Lagoon, Bottom: South Cove  
Horton's Cove is off the intersection of Beach St. and Beach Rd.  
Source: Town of Sharon DPW and Conservation Department*

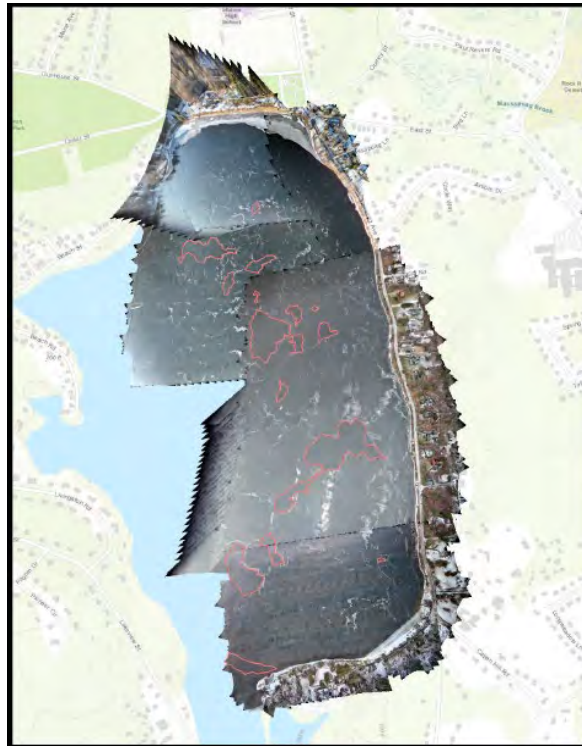
**LMAC Figure BG-11: Lake Massapoag Ice Holes from Pilot Drone Survey and Airplane**

LMAC is interested in more information on Lake Massapoag's underground springs, which are noted in older historical documents and briefly referenced in more recent ones. We requested the DPW GIS Specialist take drone photographs when there is partial icing with some open water holes in the lake and correlate it with bathymetric (depth) information to assess which areas may be fed by underground springs. A pilot survey was done in mid-December and focused on the eastern side of the lake, see **Figure BG-11** below. The red outlined areas note holes in the ice cover. This survey will be repeated when conditions are favorable and footage from the western shoreline will be added. The second photo is taken from an airplane by a resident in early February.

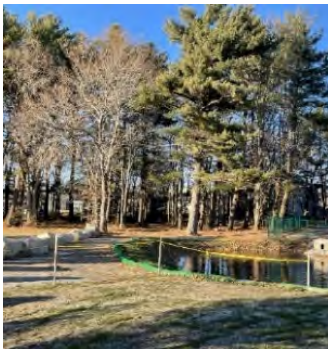
Boat Launch Redesign  
2024

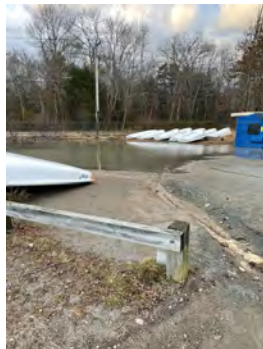
VMB West Lot Flooding  
2023

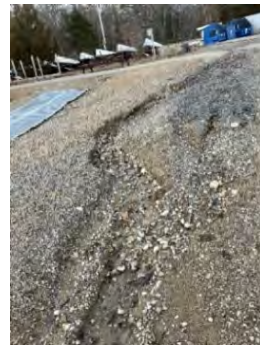
VMB West Lot Erosion  
2023

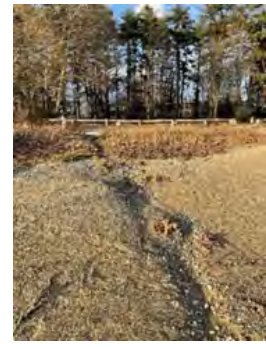
VMB East Lot Erosion  
2024

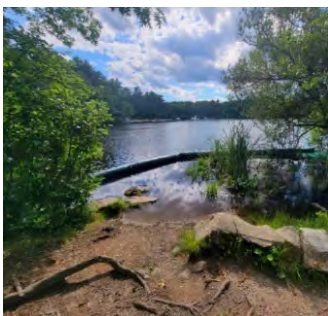
Aquatic Barrier at Lagoon

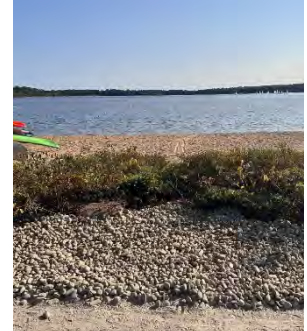
East Lot Repair 2024

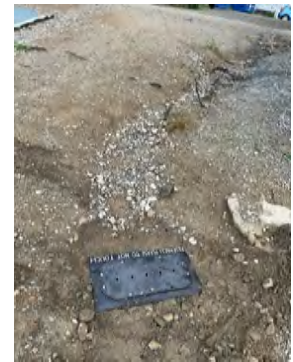
In June 2024, TRC analyzed external nutrient loading from direct stormwater runoff into the lake using unattended wet weather samplers (photo to the right). Direct runoff into the lake contained high concentrations of total phosphorus, ranging from 0.444 mg/L to 4.47 mg/L, with the highest concentrations at the **east and west ends of Memorial Beach** (2.84 mg/L and 4.47 mg/L, respectively; TRC Figure 5) (TRC Table 4).

Although not a pollutant of concern for this report, samples were also collected for total nitrogen. Total nitrogen values were elevated (greater than 1.0 mg/L) at all locations, with the west end of Memorial Beach near the dock having an extremely high concentration of total nitrogen (66.8 mg/L). This sampling indicated that significant nitrogen and **phosphorus can be mobilized directly into the lake during intense precipitation events.**

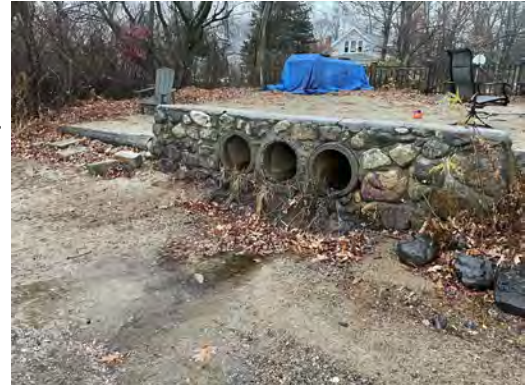
In 2024, TRC analyzed external nutrient loading into the lake from stormwater outfalls (photo to the right) and from flowing tributaries. Samples were collected during rain events to capture wet-weather conditions. Sample locations are shown in TRC Figure 6. Stormwater outfalls (sites where storm drains in the street empty into the lake) had elevated phosphorus concentrations, with **total phosphorus values ranging from 0.067 mg/L to 0.489 mg/L. The most elevated phosphorus concentrations were at outfalls located at 19-21 Livingston Road and 31 Livingston Road (TRC Table 5).**

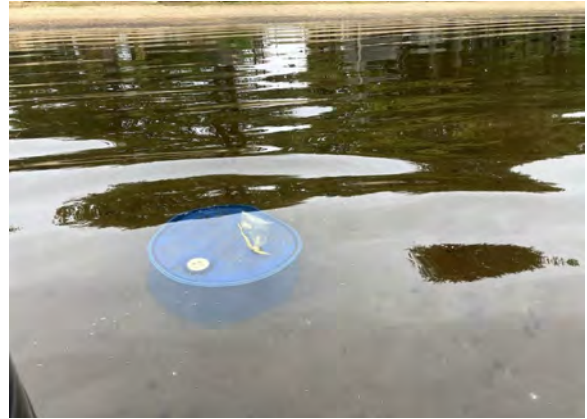
In September 2024, TRC measured groundwater seepage rates and groundwater quality in shallow areas (up to 10 feet deep) of Lake Massapoag along the shoreline (photo to the right). Sample locations are shown in TRC Figure 7. On the day of the survey, seepage of groundwater was predominantly positive, suggesting net in-seepage of groundwater to the lake. Measured groundwater quality showed dissolved phosphorus concentrations in shallow groundwater were above 0.025 mg/L and total nitrogen were above 1.0 mg/L at all locations.

Daily loads of dissolved phosphorus and total nitrogen into the lake were then calculated by multiplying the seepage rate with the associated concentration (Table 6).

Based on these results, it is **likely that phosphorus and nitrogen concentrations in groundwater seepage are being influenced by human activity (e.g. septic systems and/or fertilization)** from the surrounding land. This analysis does not account for groundwater seepage in deeper areas of the lake. Given that Lake Massapoag is also fed by underwater springs, it is important for future testing to analyze the potential phosphorus loading from groundwater springs.

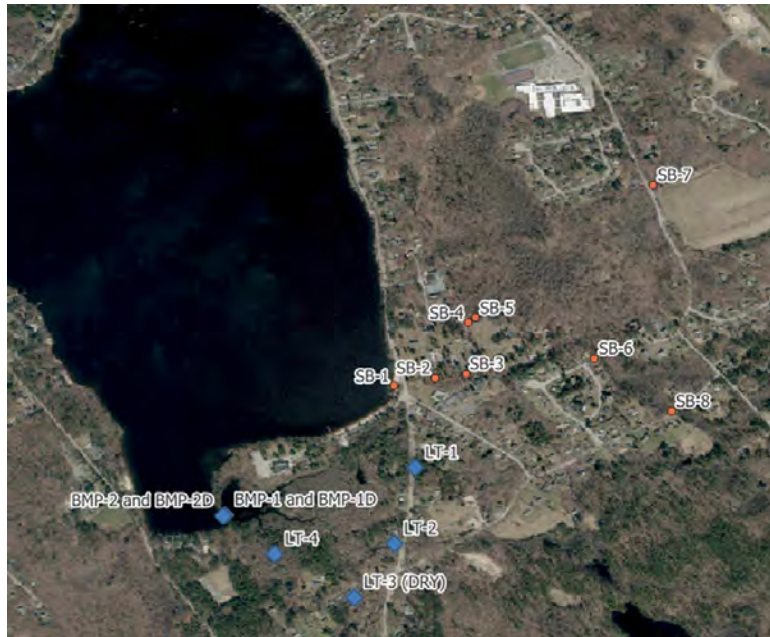
**TRC Figure A-8: Hot Spot Survey Locations along Sucker Brook, the Lagoon and its Tributaries**

*Note: Sucker Brook locations are shown in orange; lagoon and tributary sampling locations are in blue.*

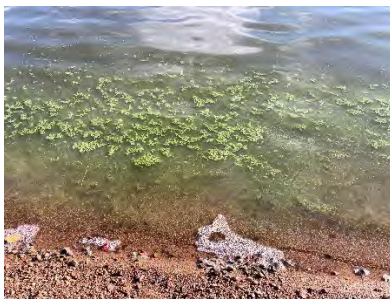
**Cyanobacteria October 2021**

LMAC began testing cyanobacteria levels in 2022, using a handheld fluorometer to measure the levels of phycocyanin, a photosynthetic protein that is found only in cyanobacteria. In 2022 we measured levels in the deep hole and added measurements at Veterans Memorial Beach (VMB) and Everwood Day Camp in 2023 - 2025. We also recorded sightings in EPA's BloomWatch app until it experienced technical difficulties.

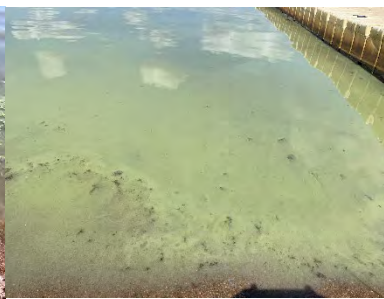
**Cyanobacteria September 2023**

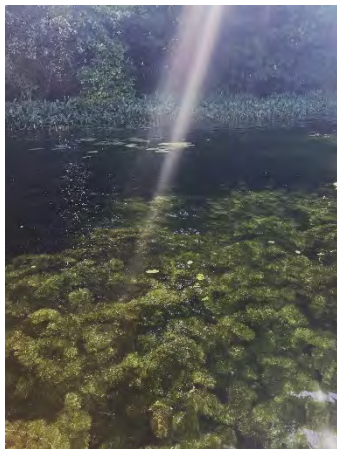
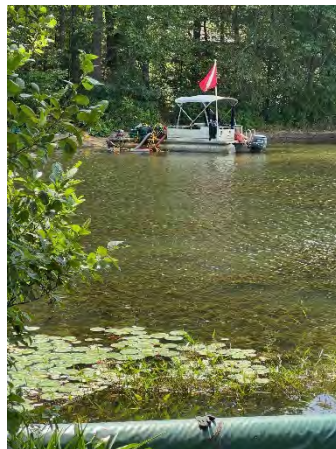
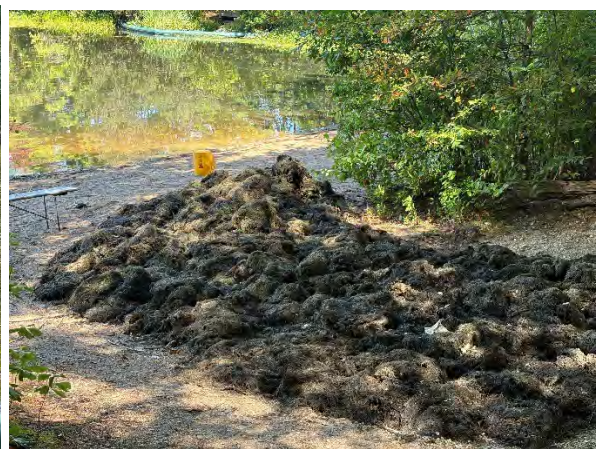
**Pre-Dash S. Cove Aug. 2022    DASH S. Cove late Aug. 2025    Post-DASH S. Cove weeds early Sept. 2025**

In 2024 and 2025, LMAC was able to increase to 20-22 days of DASH, due to the prior grant from CPC and an annual donation from Everwood Day Camp. In 2025, fanwort and milfoil expansion was additionally fueled by the alum treatment. While phosphorus levels were reduced, the increase in water clarity allowed more sun to reach the plants in the shallow coves. NEAS estimates 35 days of DASH are needed in the coves in 2026. LMAC is seeking funds for the recommended 35 days of DASH in 2026. Most of the DASH to date has been directed in the South Cove, but there is marked expansion of fanwort in Fletcher's cove which must be addressed.

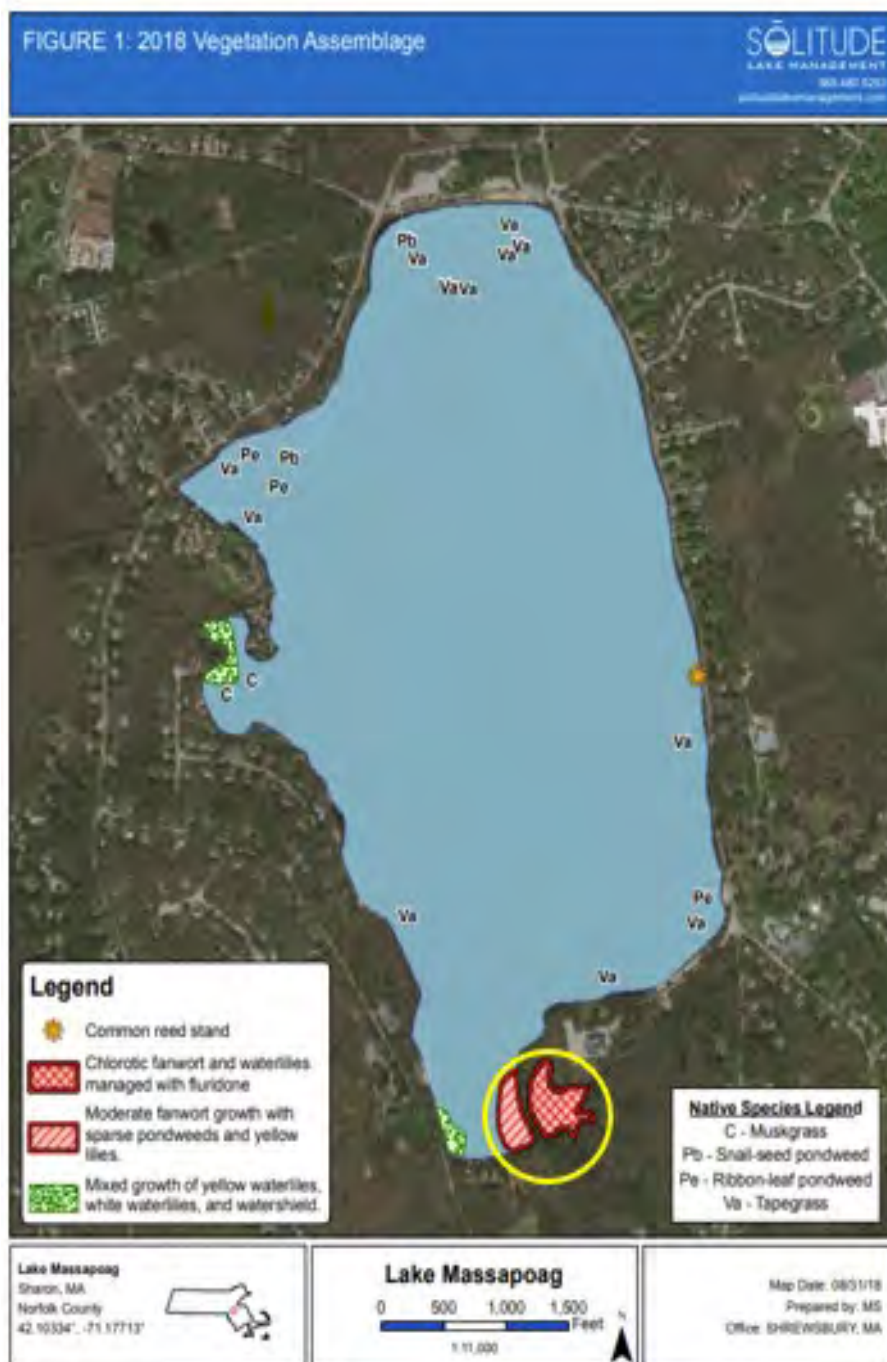
**SOLitude Figure A-15: Weed Maps/Vegetation Assemblage in Lake Massapoag 2018**

*Note: Areas of variable-leaf milfoil and fanwort are circled in yellow.*

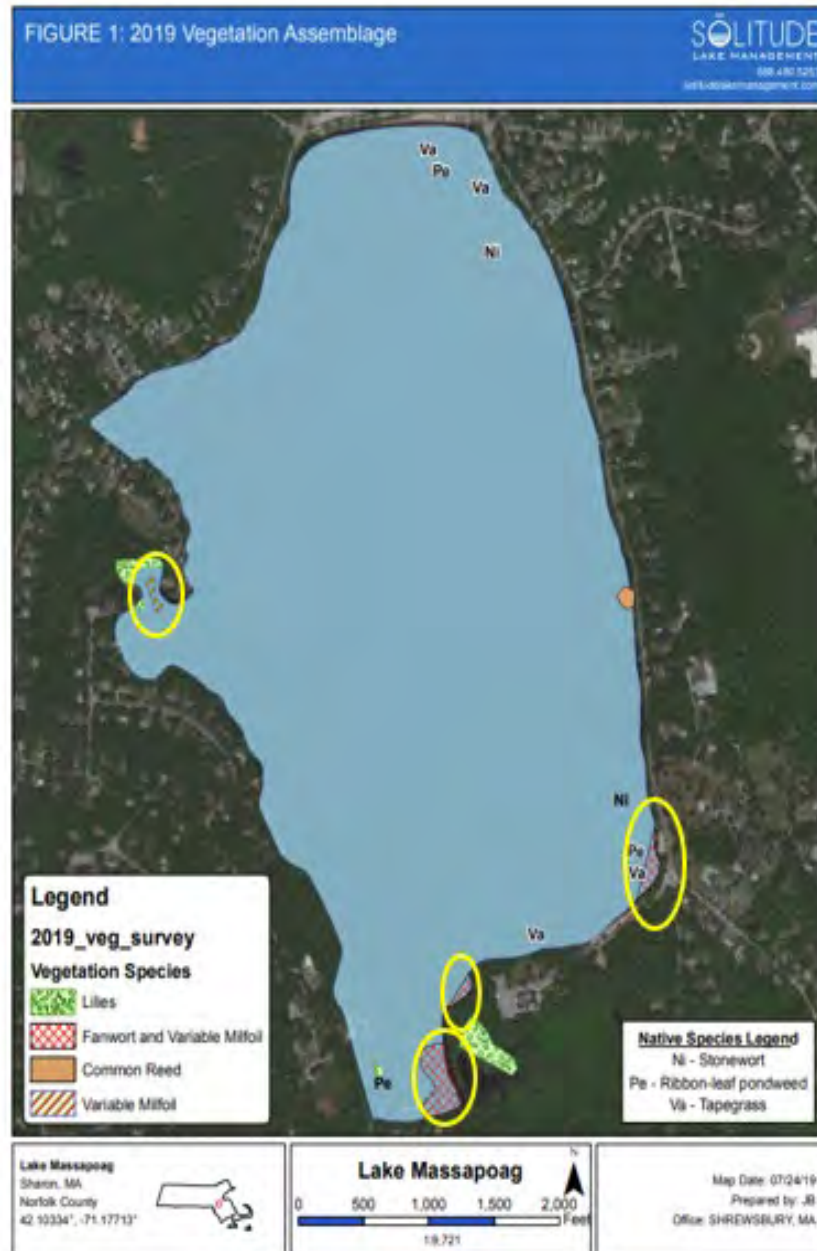
**SOLitude Figure A-16: Weed Maps/Vegetation Assemblage in Lake Massapoag 2019**

*Note: Areas of variable-leaf milfoil and fanwort are circled in yellow.*

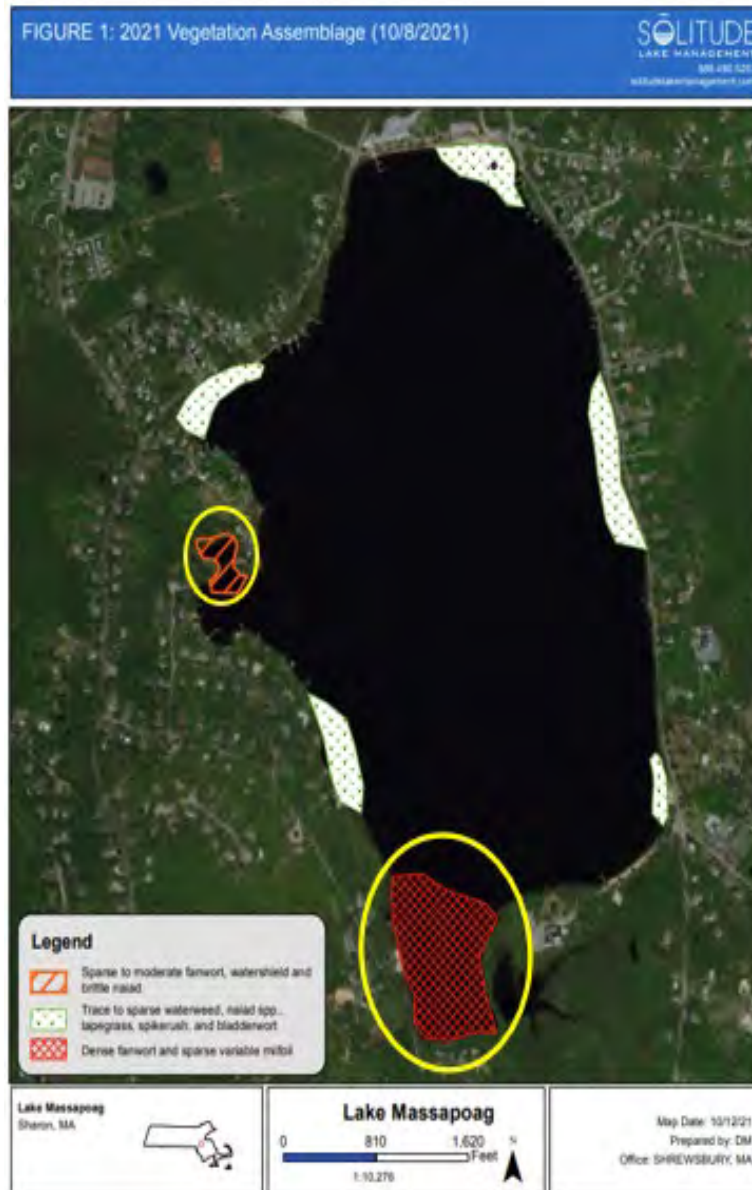
### **SOLitude Figure A-18: Weed Maps/Vegetation Assemblage in Lake Massapoag 2021**

*Note: Areas of variable-leaf milfoil and fanwort are circled in yellow.*

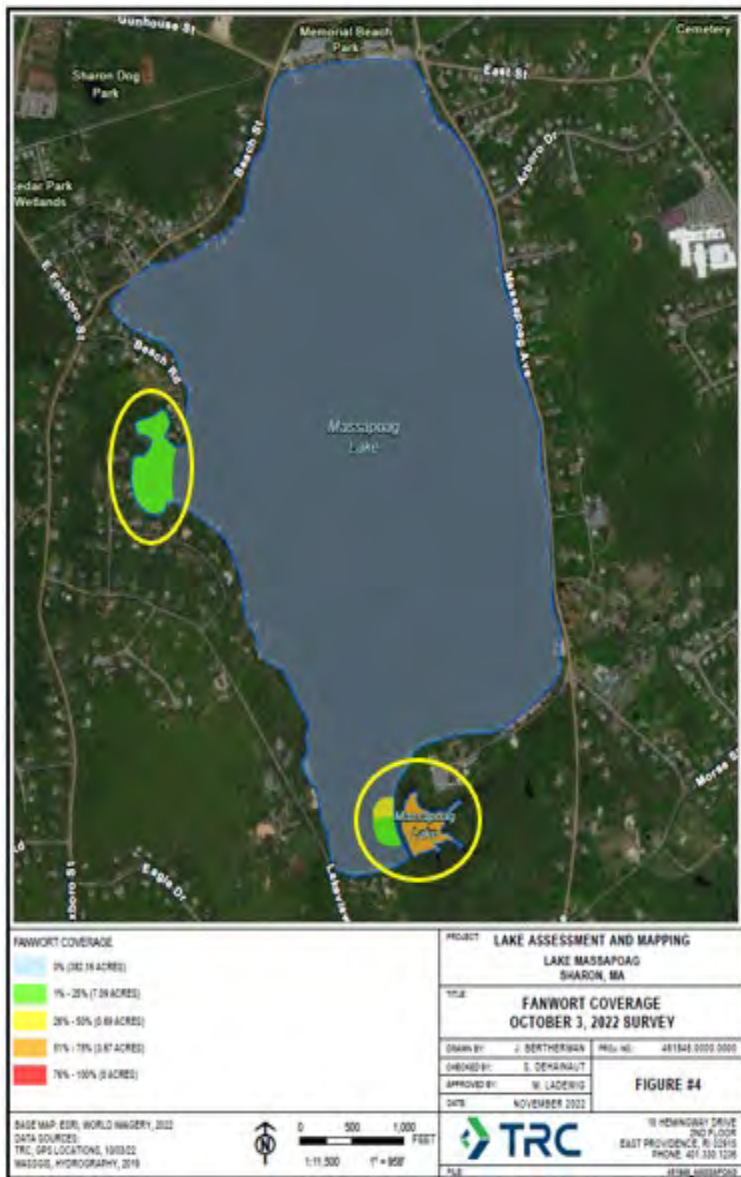
**TRC Figure A-19: Fanwort Coverage in Lake Massapoag 2022**

*Note: Areas of fanwort are circled in yellow. Source: TRC, 2023*

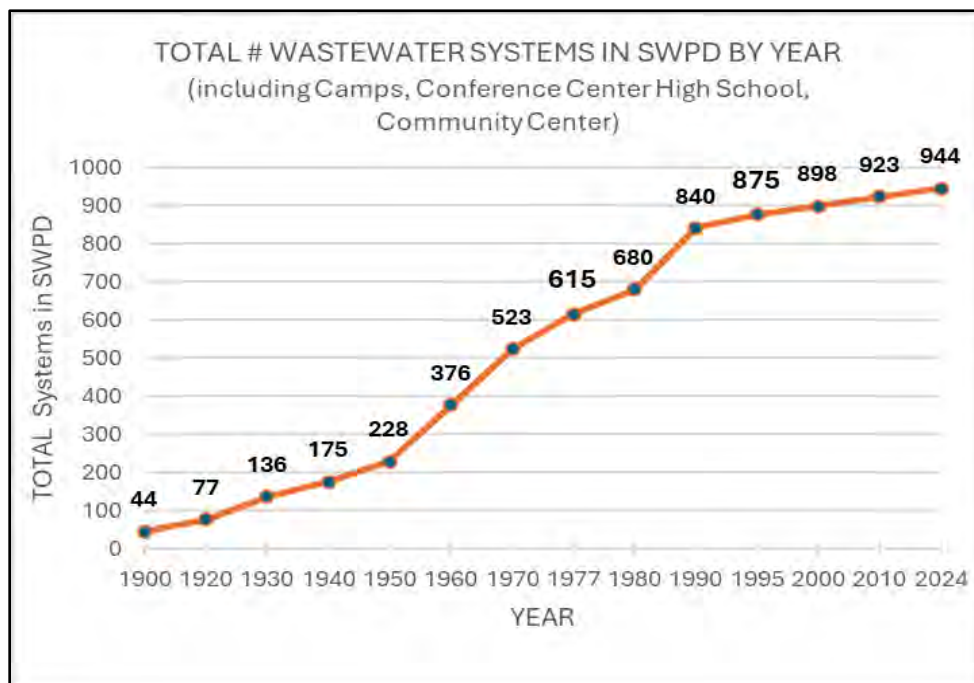
**LMAC Septic Figure B-1: Total Wastewater Systems in Surface Water Protection District by Year**

The number of homes and facilities located in the Surface Water Protection District has grown considerably over the past 125 years, see Figure B-1. It includes 928 residences and two small houses of worship, small commercial sites and institutions, and the Sharon High School and Middle School wastewater system, Veterans Memorial Park Beach, Sharon Community Center, Salvation Army's Camp Wonderland and Conference Center, and Everwood Day Camp.

The lake watershed lacks sewers, and a **large number of homes are within 300 feet of either the lake, or a tributary or wetland that feeds the lake**. Over time, septic leaching fields and soils can become saturated with phosphorus and no longer attenuate it. When the binding sites for phosphorus in soil become saturated, phosphorus levels will begin to increase in the groundwater. There is evidence of this based on data from groundwater monitor wells at Sharon High School (Average Total Phosphorus, Average Dissolved Phosphorus). Because of this, LMAC considers that the phosphorus load from human wastewater may be above what the LLRM model predicts.

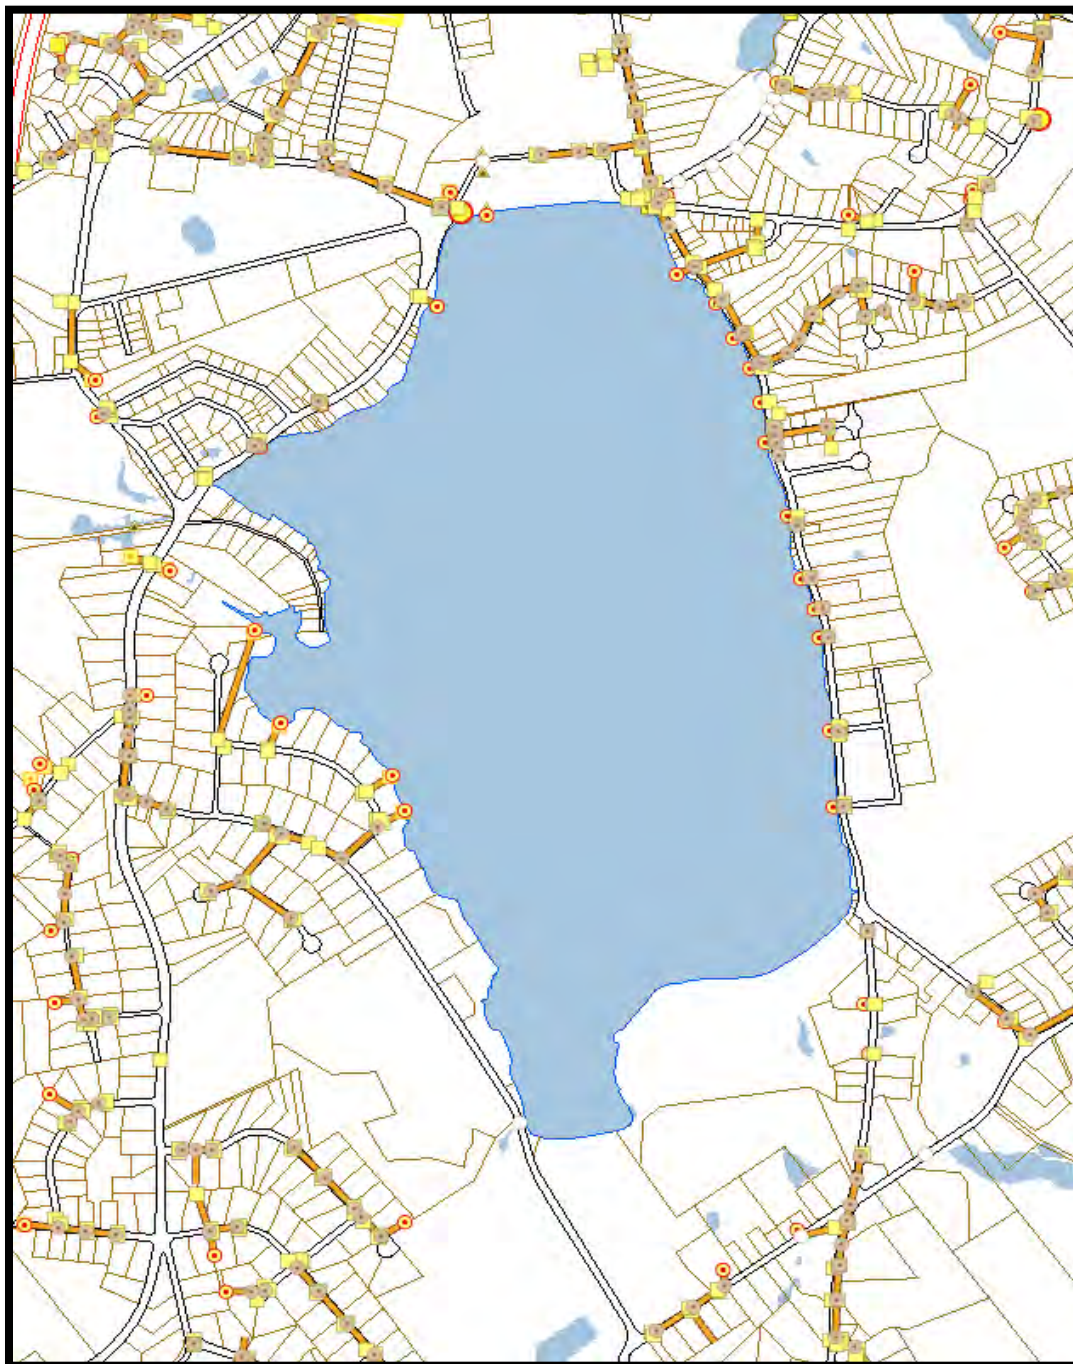
**LMAC Figure C-2: Storm Drain Details around Lake Massapoag**

Figure C-2 below illustrates the storm drains around Lake Massapoag for background.

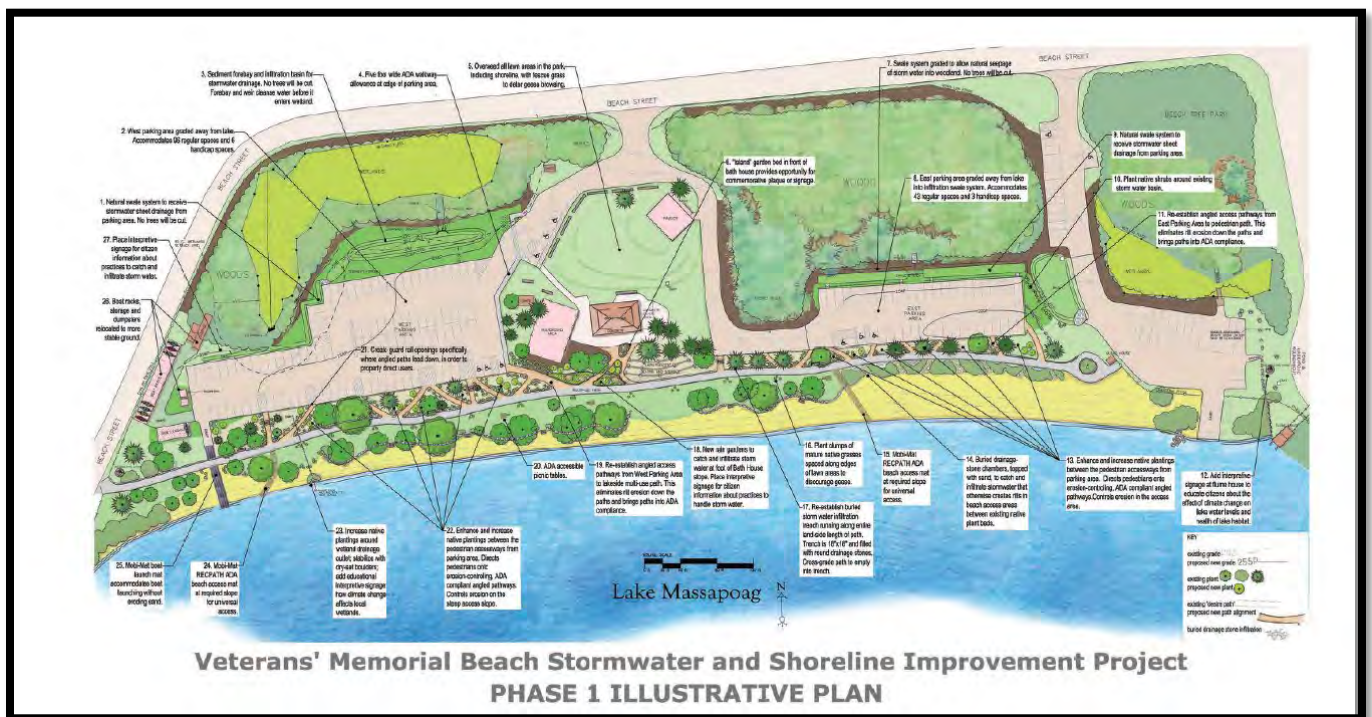
**LMAC Figure C-5: Veterans' Memorial Park Beach Stormwater and Shoreline Improvement Project**

DPW has now designed a plan for needed drainage improvements, porous paving, green infrastructure, and plantings to regrade, resurface, and add drainage, erosion control, and nutrient runoff control measures to the West and East parking lots at Veterans Memorial Beach. The project will be done in two stages, so that one of the lots remains open during construction. LMAC has added a shoreline improvement plan designed by Raingarden Design Studio and interpretive signage. See **Appendix A** for conceptual and engineering drawings, permits, budgets, TSS calculations, and Hydro CAD.

For additional project information and DPW engineering drawings, see **Appendix A**, projects 1 and 2.

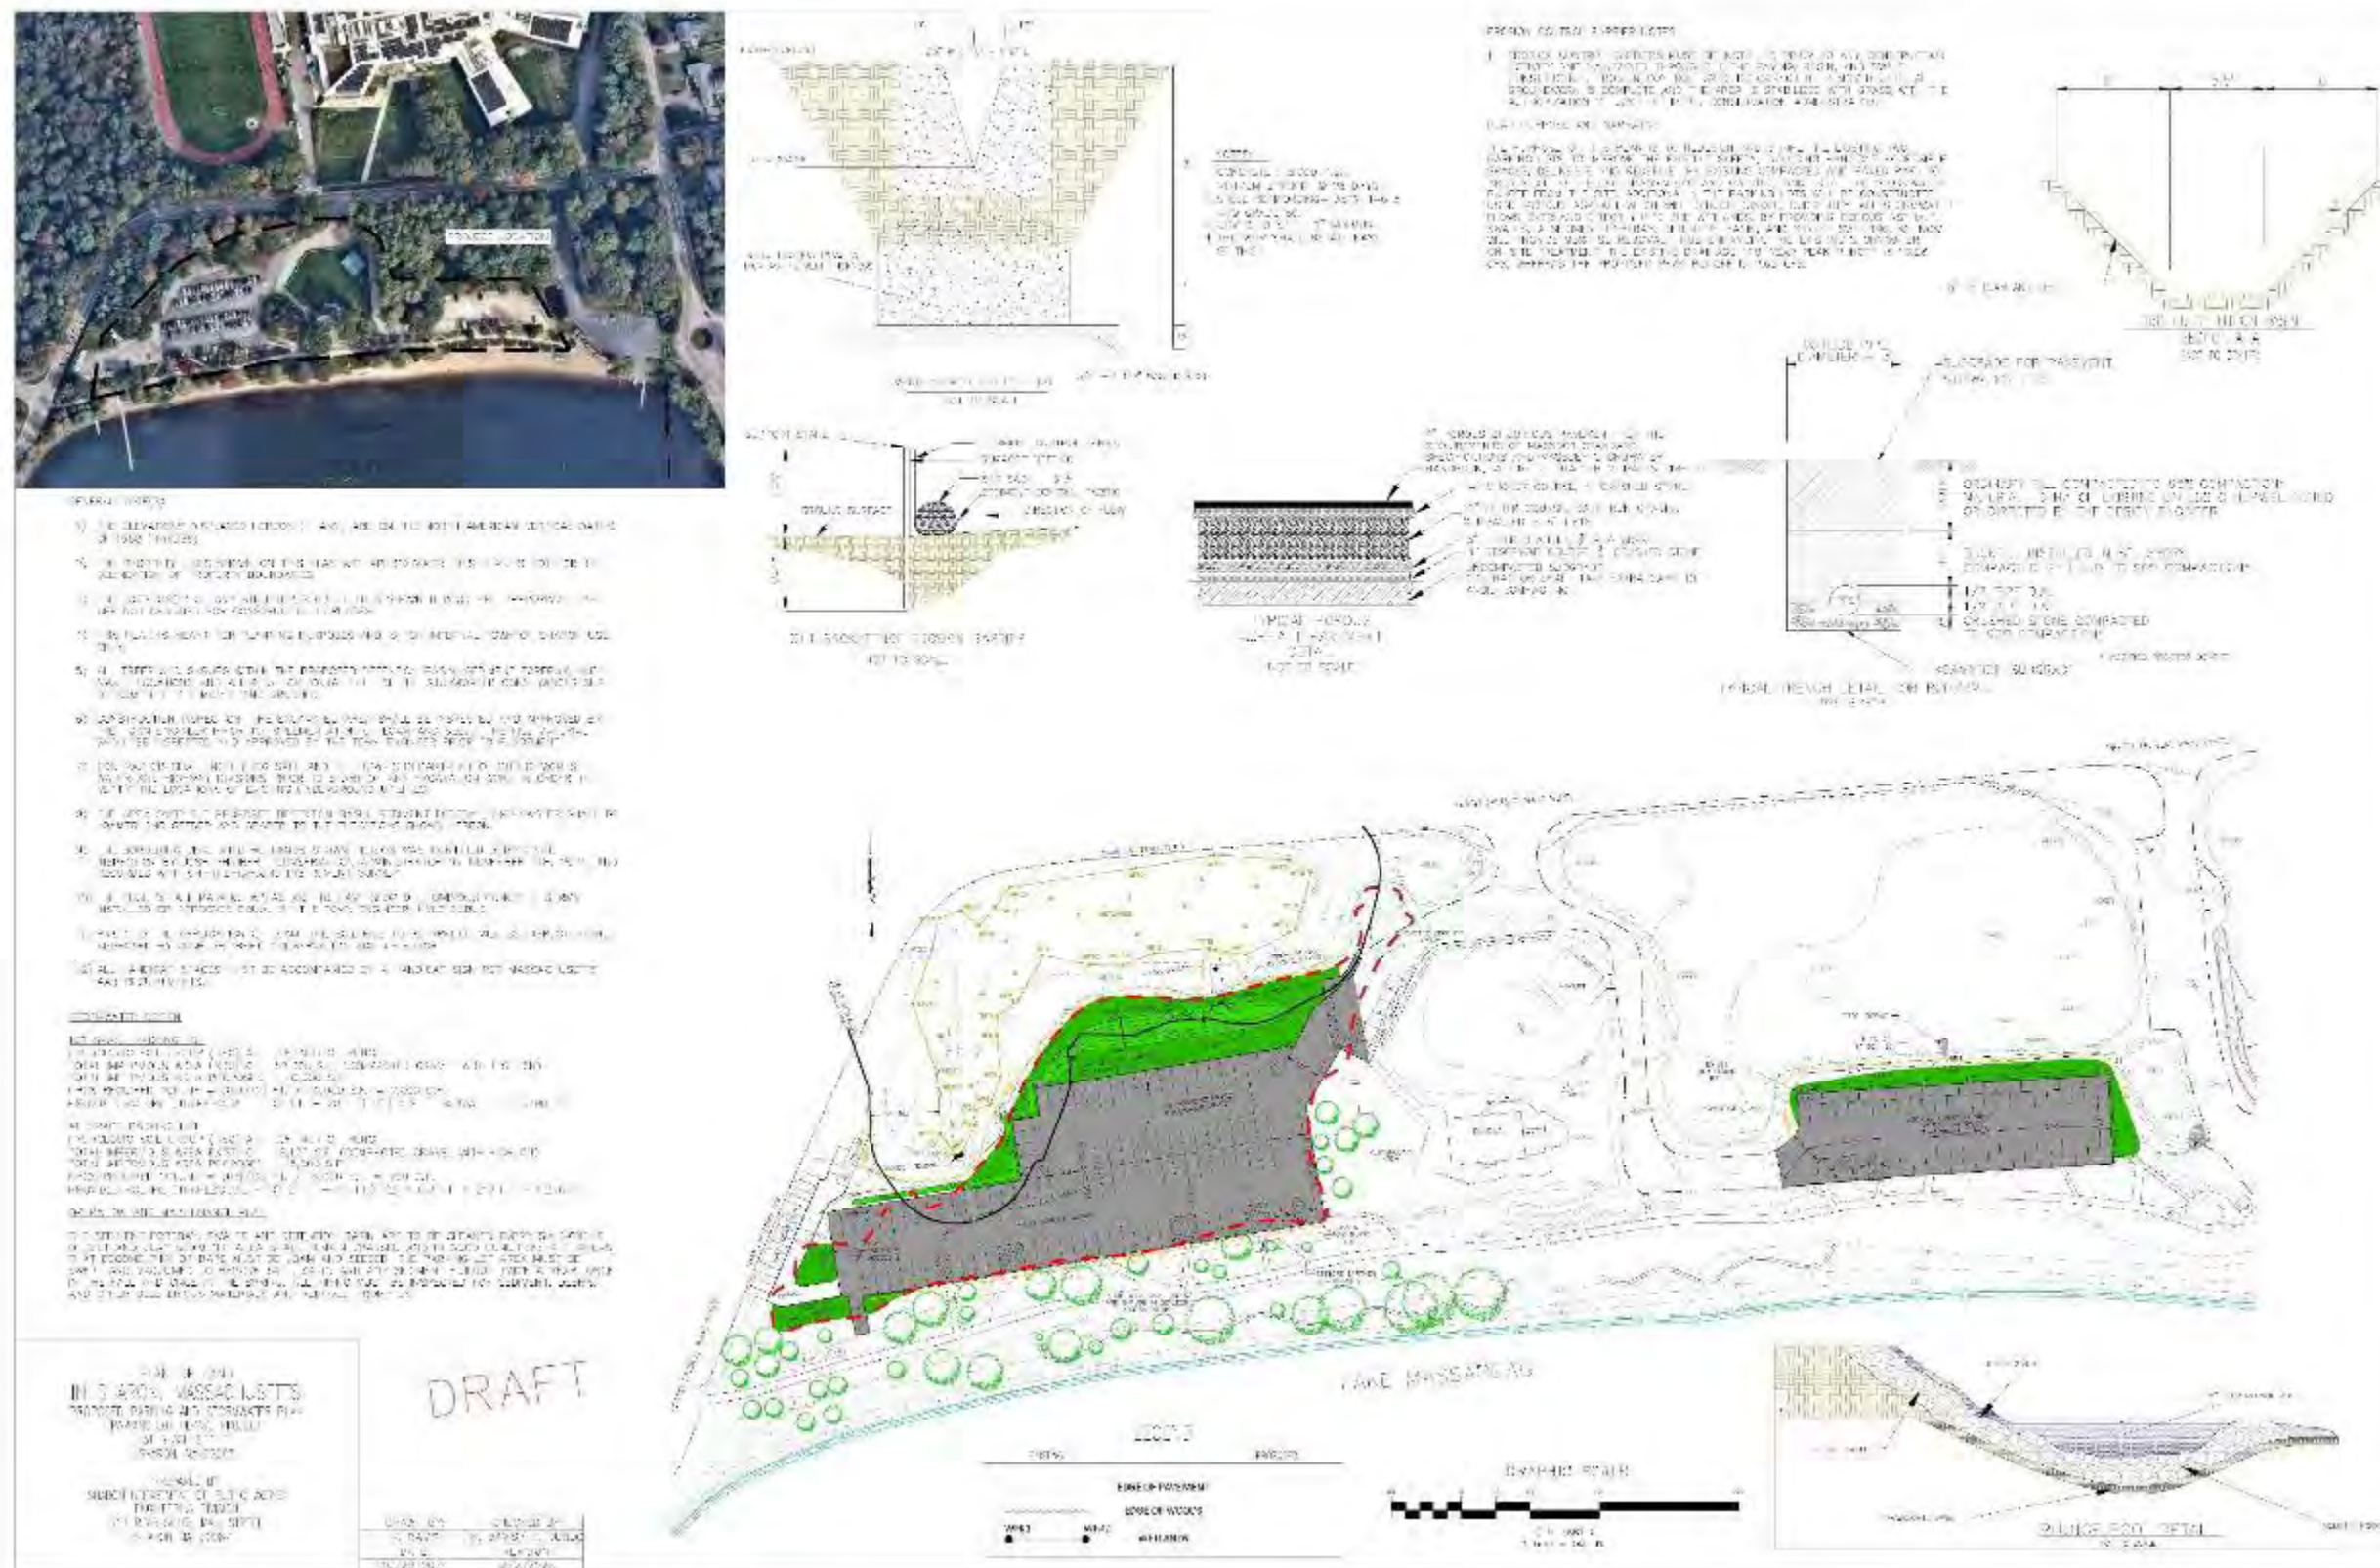
## Engineering Drawing: Veterans' Memorial Beach Improvements

Excess Phosphorus, Drainage, and Erosion Challenges to be Addressed:  
Major Redesign of the West and East Parking Lots, Drainage, Shoreline, Plantings, & Walking Paths with Interpretive Signage Using Nature-Based Solutions

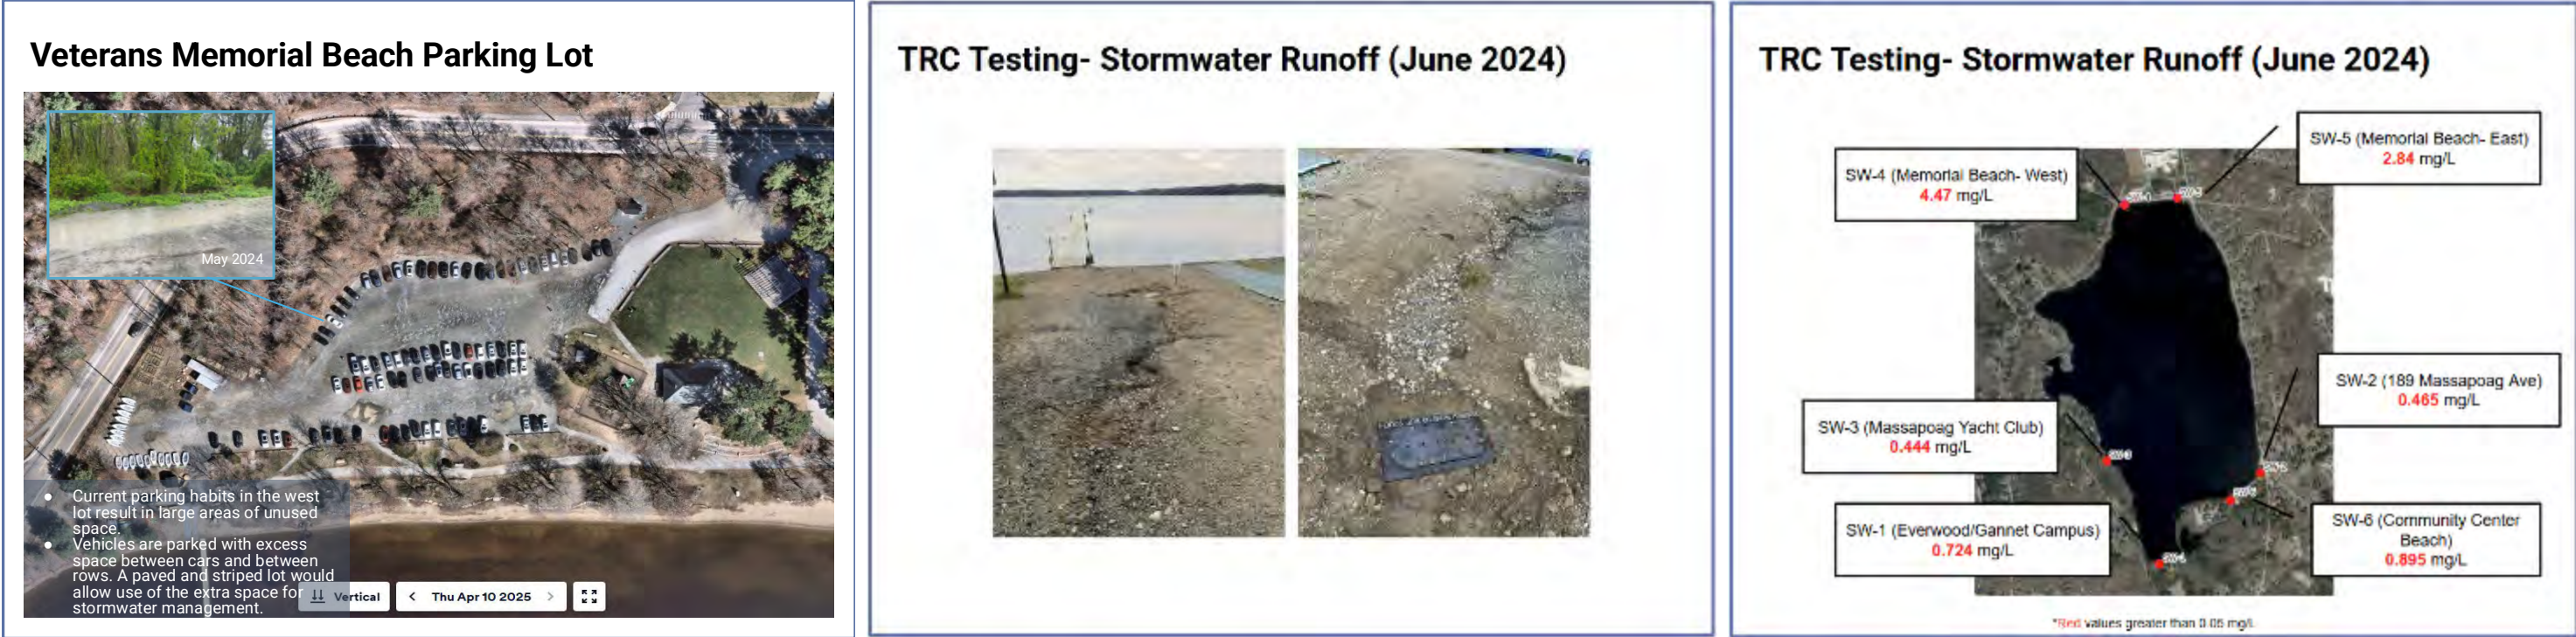
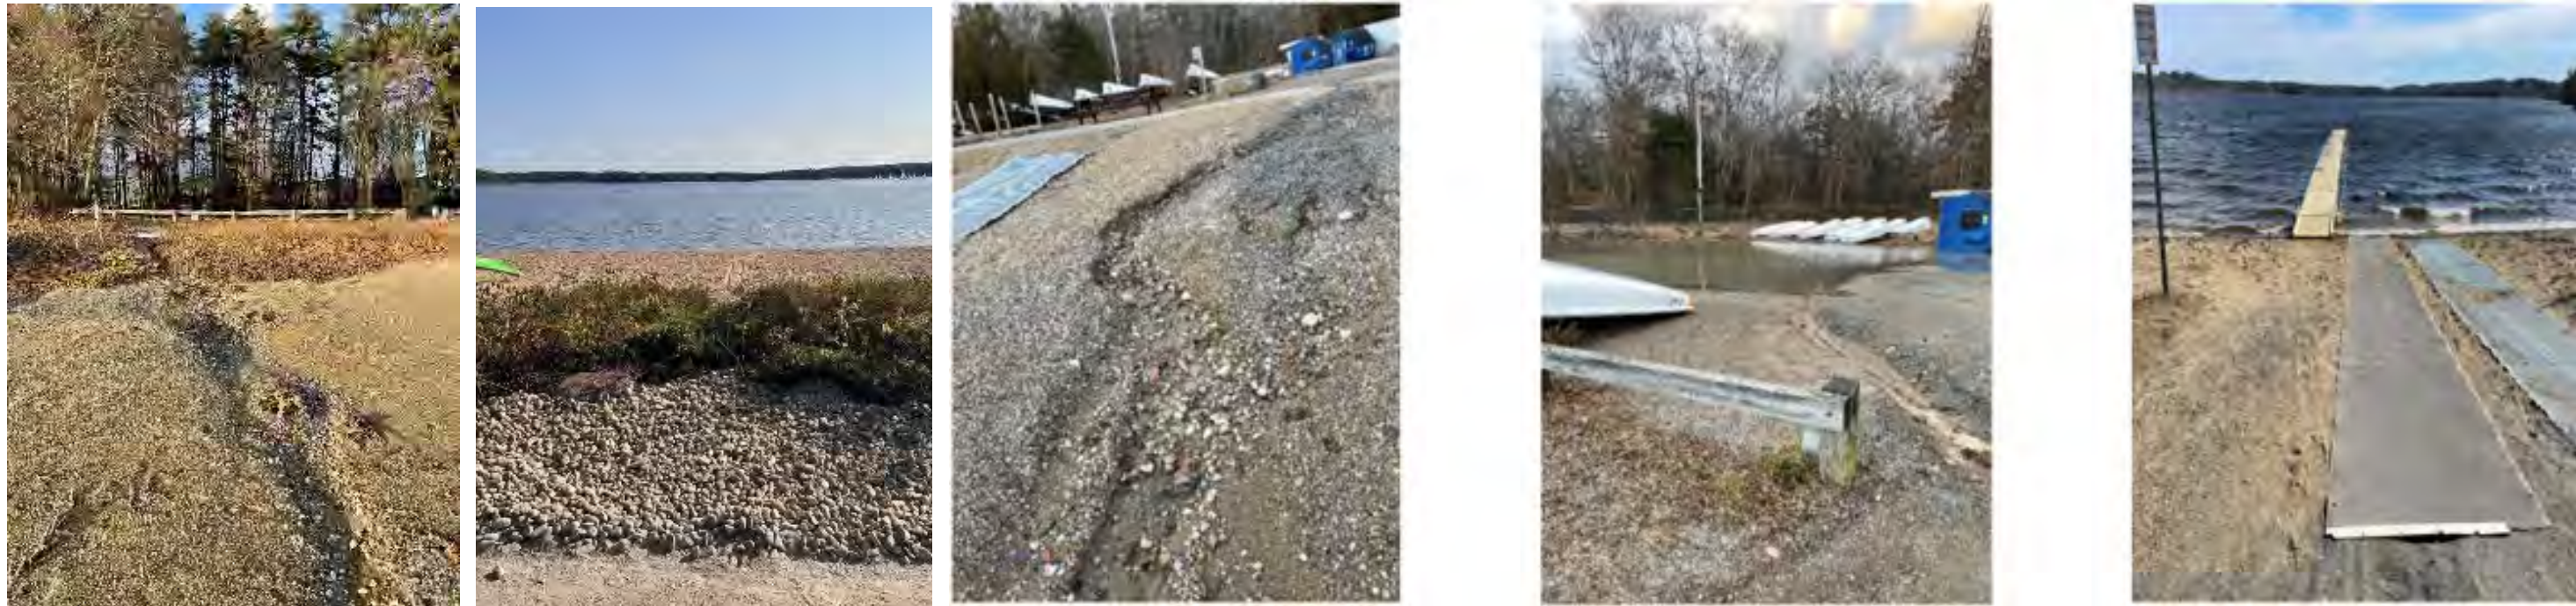
VMB East Runoff Erosion Feb 2024      VMB East Interim Repairs Sept 2024      VMB West Lot Erosion Sept 2024      VMB West Lot Flooding Erosion Runoff      VMB West Interim Repairs Oct 2024

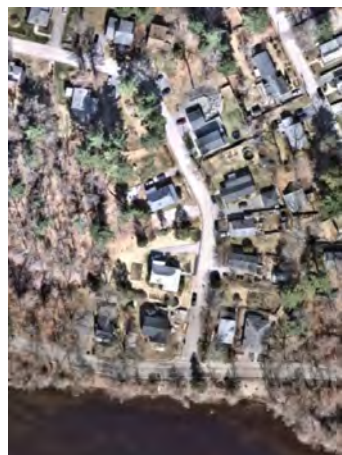
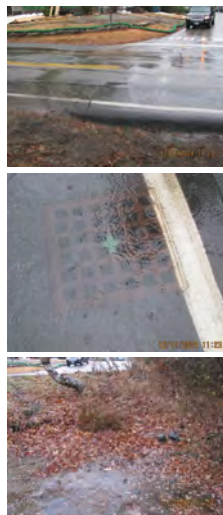
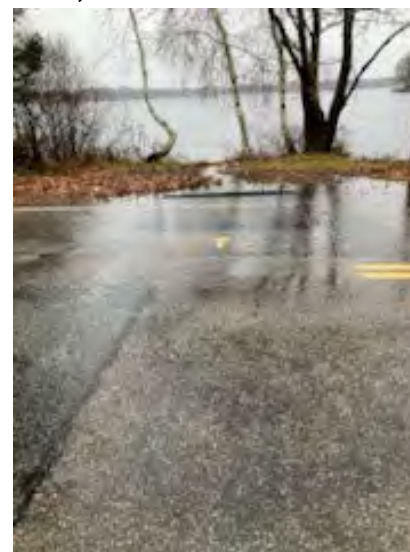
**Lake Avenue and Beach Street**

Town added the berm to redirect runoff down Lake Ave and a storm drain to collect it; it is not sufficient for heavy rainstorms.

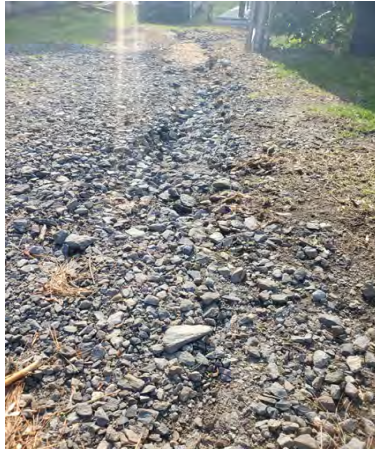
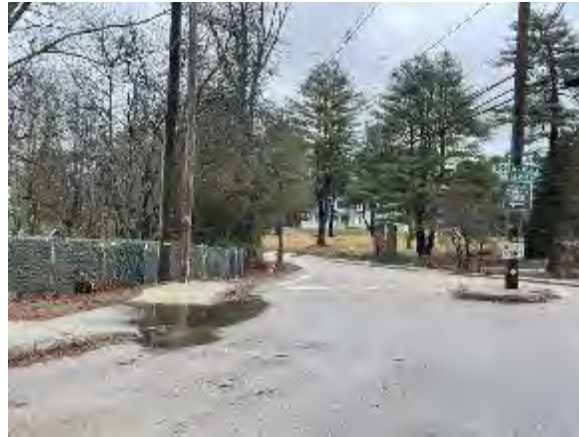
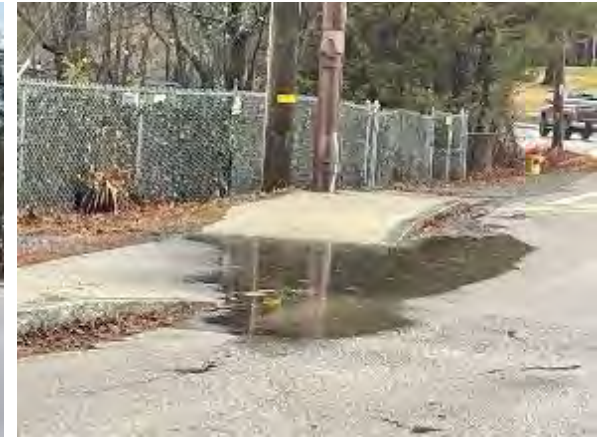
Top left: May 2023 washout from flooding at 189 Massapoag Ave, bottom of Capen Hill Rd. Top center and right: March 2025 pooling; stormwater runoff enters curb cut. Installed two French drains, geese deterrent low fencing, added 4 tons of gravel and 8 tons at 187 Massapoag Ave, planted 10 evergreen trees. Bottom: shoreline after heavy rain mid-August 2025. Requests full granite curb to help mitigate, which will also deflect some of the water down the street. The uphill source of problem also needs to be addressed through additional storm drains on Capen Hill Rd and a system for infiltration.

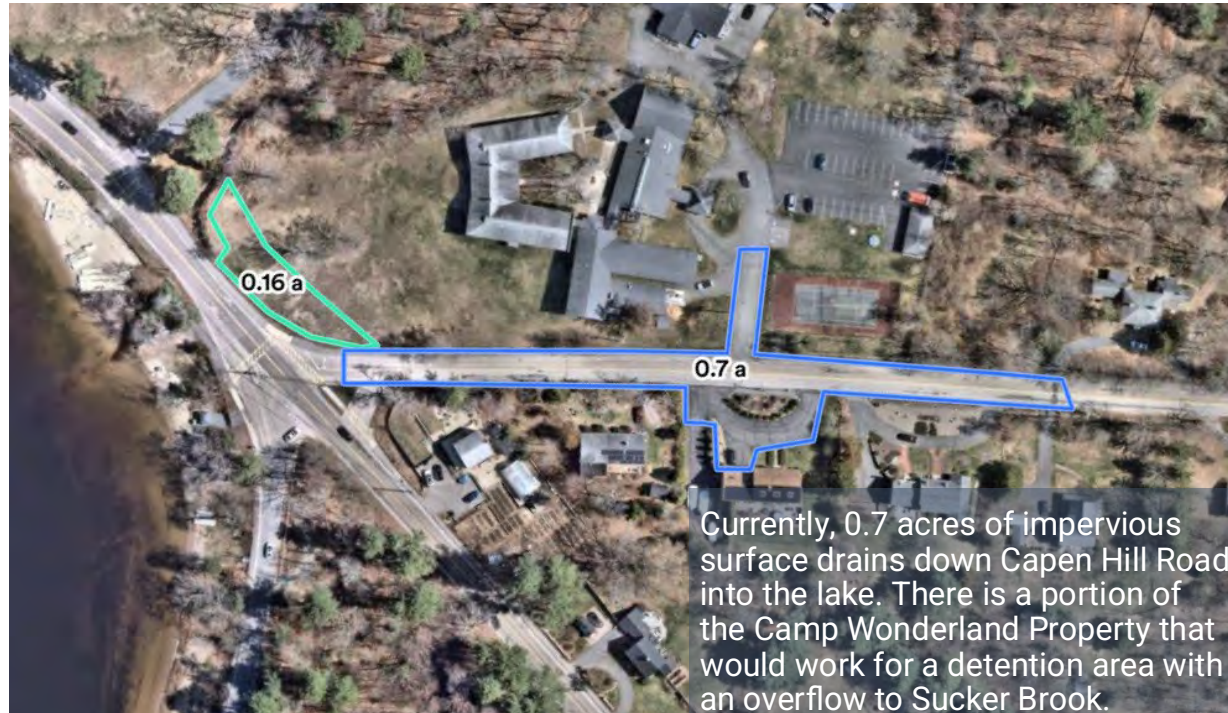
## Potential for Detention Basin for Capen Hill Road

Note: The Town Conservation Administrator asked the Salvation Army if it would consider allowing adding a constructed wetland to its property to divert and infiltrate runoff down Capen Hill Rd, but the organization declined on the advice of counsel. A more extensive drainage and diversion project will need to be designed. It will examine the capability of storm drains to be installed to direct stormwater into the wetlands behind the Community Center for greater attenuation and seasonal phosphorus control. Regarding beach flooding at the bottom of the hill, the owner has done some remediation by adding a pit of gravel at and is exploring options for the adjacent parcel they purchased. LMAC asks the Town to consider restoring the full granite curb
