## WATERSHED-BASED PLAN

Lake Massapoag (MA73030)

2026-2050

Sharon, Massachusetts

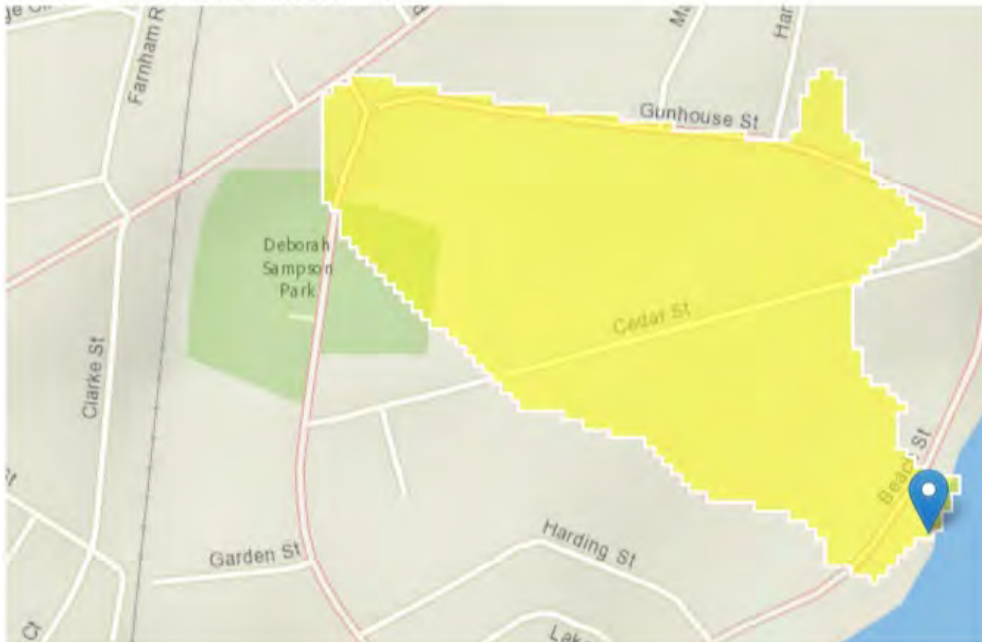
## Mid Beach St StreamStats Report

**Region ID:** MA  
**Workspace ID:** MA20230301193824242000  
**Clicked Point (Latitude, Longitude):** 42.10758, -71.18156  
**Time:** 2023-03-01 14:38:45 -0500

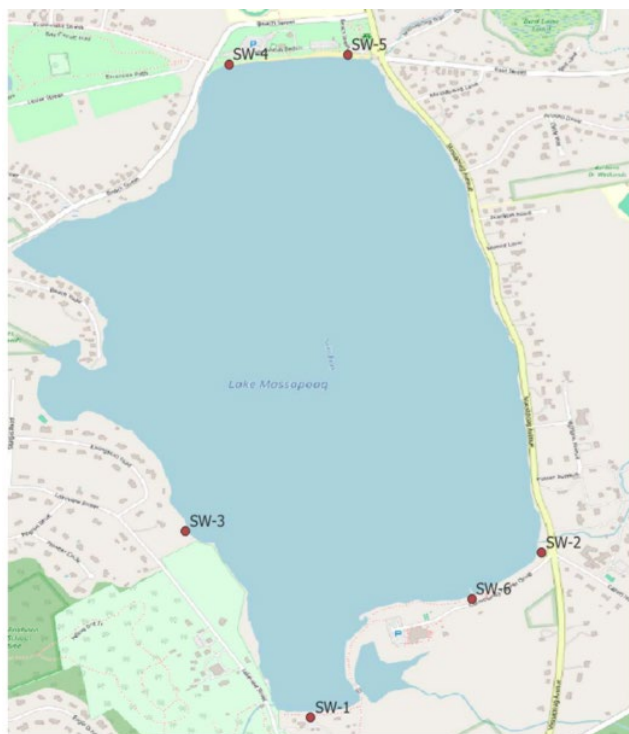
**Figure 1.** Results of wet weather shoreline sampling and map of sampling locations, from TRC memo November 20, 2024.

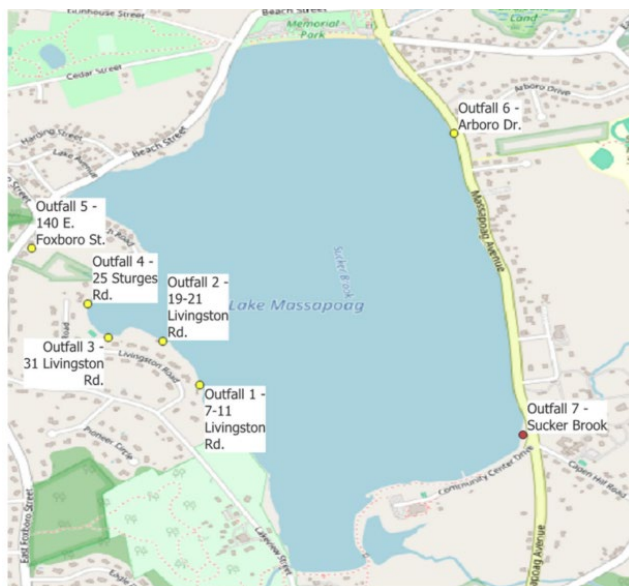
**Figure 2.** Results of storm drain sampling and map of sampling locations, from TRC memo January 13, 2025.

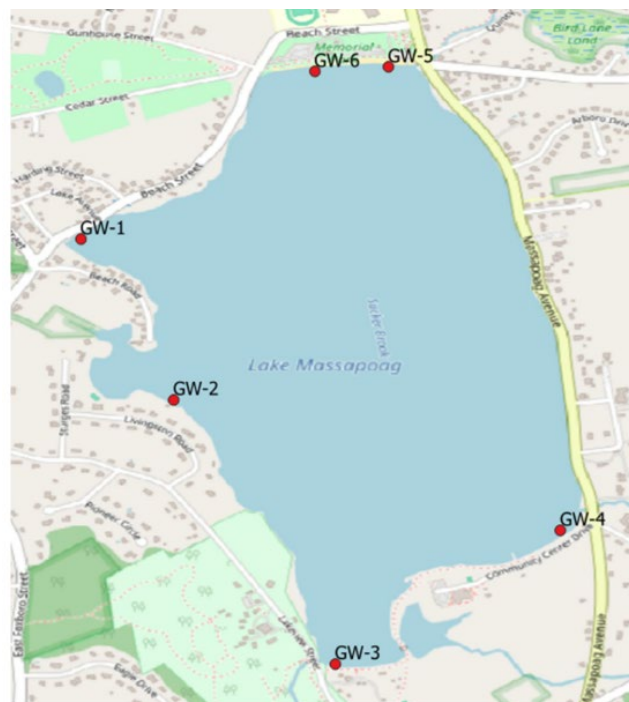
**Figure 3.** Results of groundwater seepage survey and map of sampling locations, from TRC memo October 28, 2024.

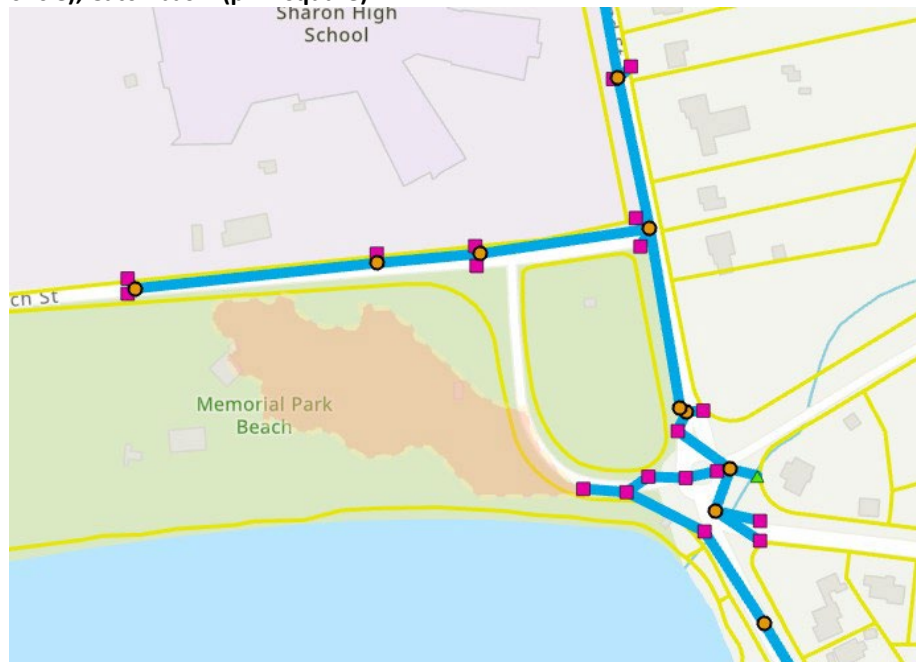
**Site Map: Catchment Area (orange), Parcel (yellow), Outfall (green triangle), Storm pipe (blue line), Man Hole (orange circle), Catch basin (pink square)**

**Suggested BMP Area:** Parking lot or adjacent area

**Proposed BMP Type:** Rain Garden, Bioretention Cell, Infiltration Cell, Sediment Forebay, Permeable Pavement

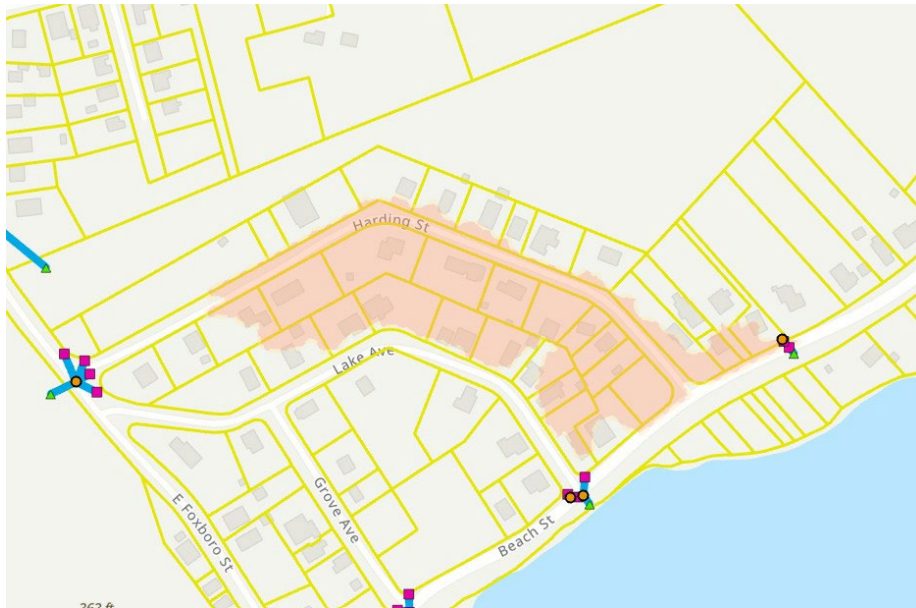
**Site Map:** Catchment Area (orange), Parcel (yellow), Outfall (green triangle), Storm pipe (blue line), Man Hole (orange circle), Catch basin (pink square)

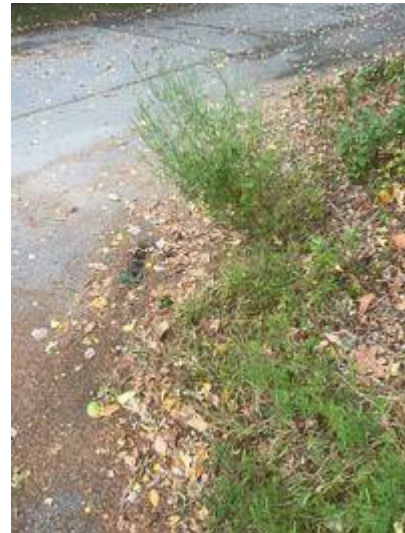
**BMP Photo 1**

**BMP Opportunities:** ROW space (see note in other)

**Proposed BMP Type:** Sediment Forebay, rain garden,

**Other:** ROW is wider than current street, available area along Beach St that is town owned. Additionally, Lake Ave has history of flooding issues due to water running down Lake Ave during wet weather.

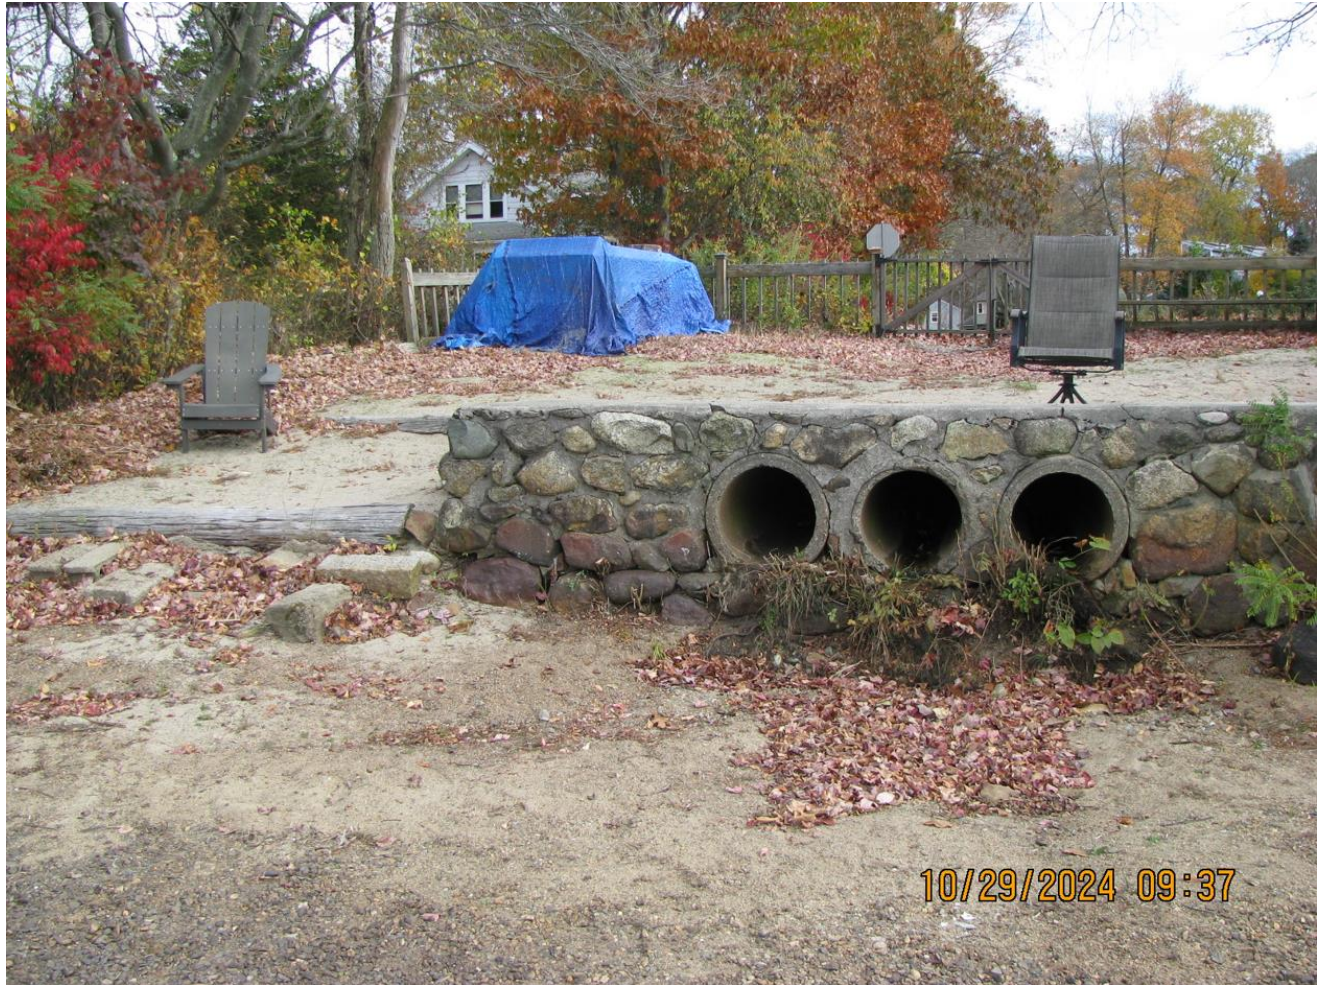
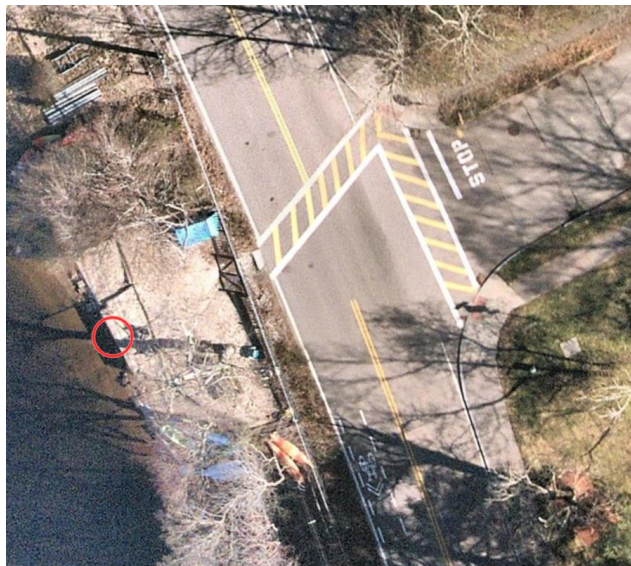
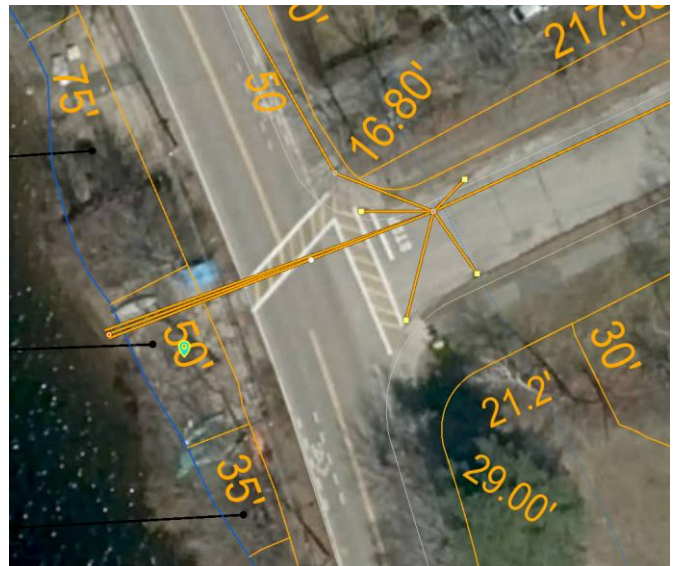
1. Parcel is 55 Massapoag Ave. Owner – Evelyn Rohrbacher. Three pipes cast into retaining wall across from Arborio Drive. No drainage easement or public property nearby. Access from the water or through the woods between parcels. Shown on GIS Drainage Group.

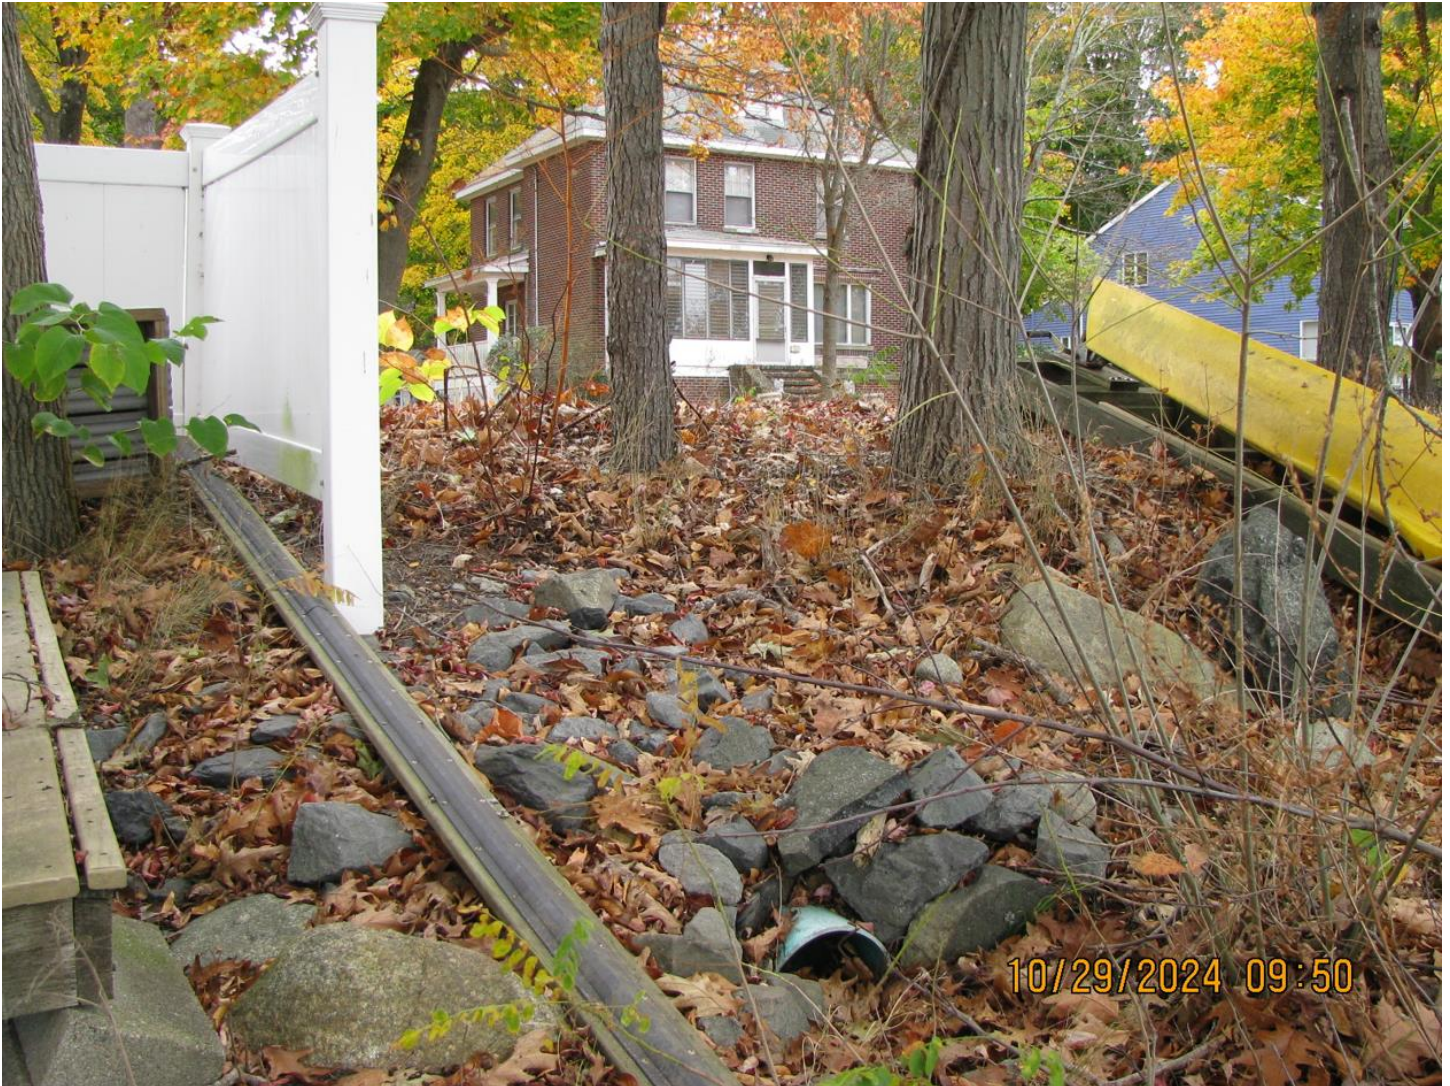
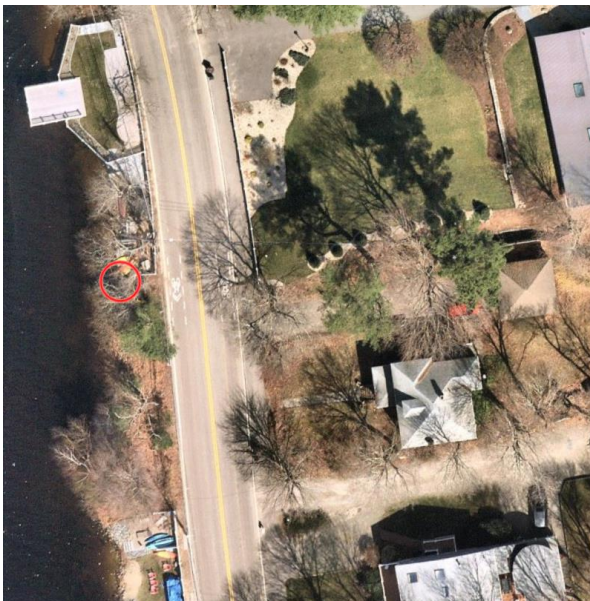
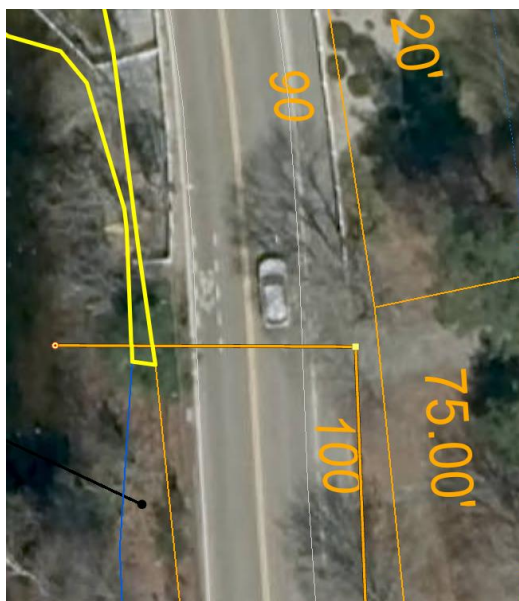
2. Parcel is the waterfront at 90 Massapoag Ave. between the house lots for 90 and 100 Massapoag Ave. (these are adjacent parcels). Owner – William Tanzer. The pipe is across from the driveway for 100 Massapoag Ave. Access is off the street by the fence. No easement present. Shown on GIS Drainage Group.

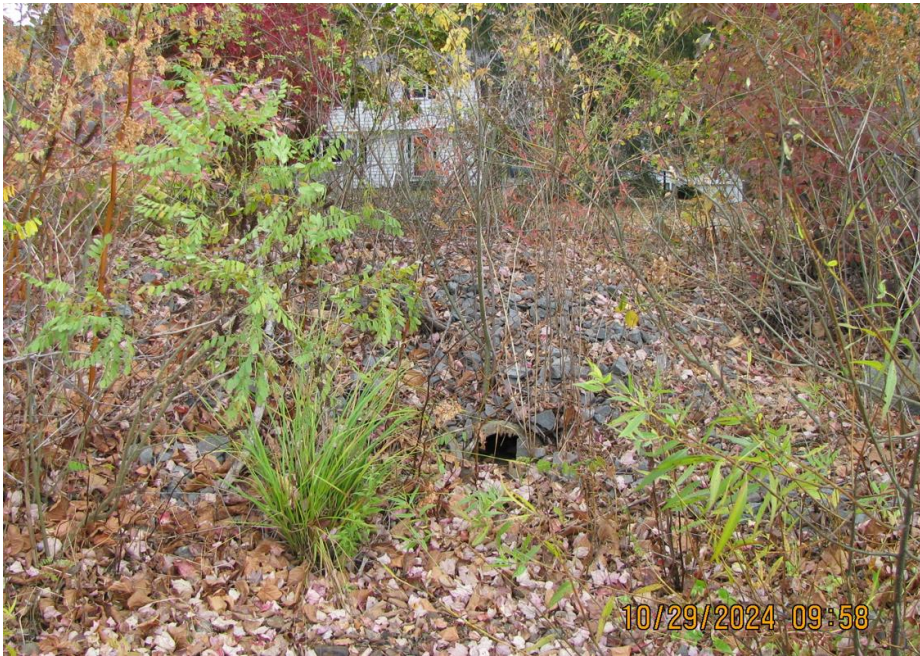
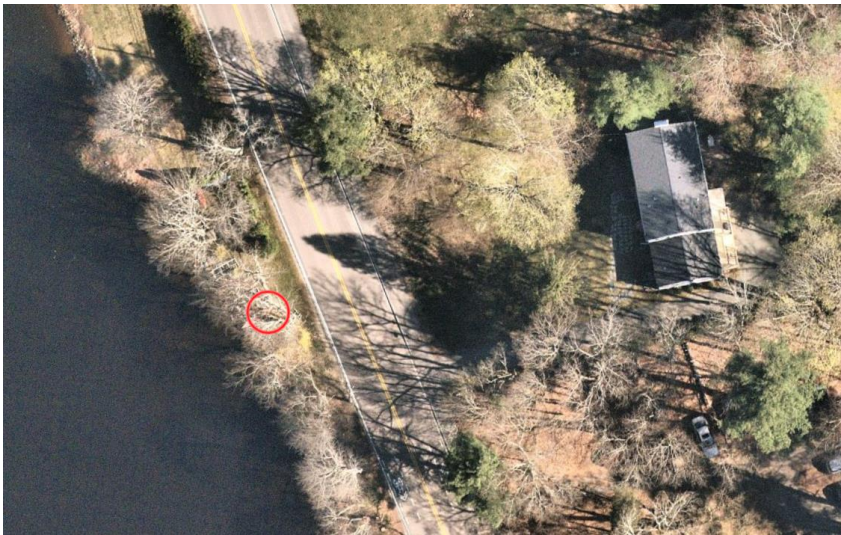
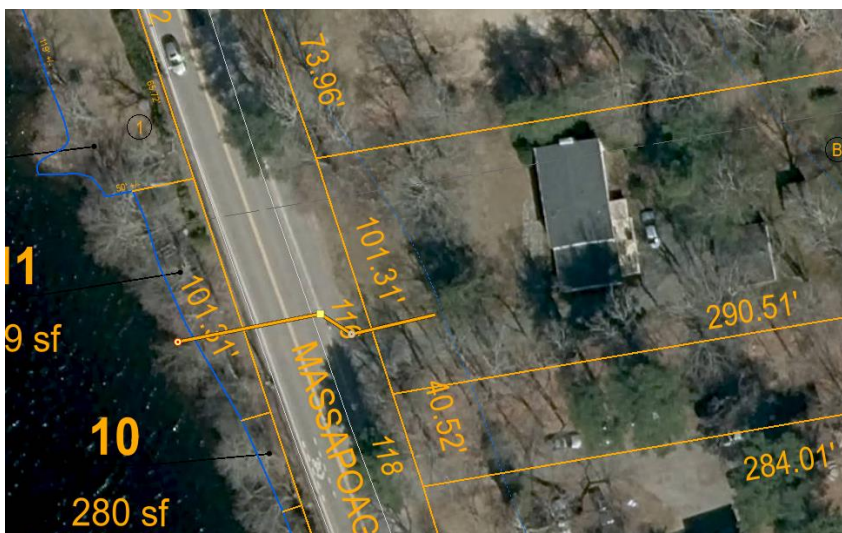
3. Parcel is 116 Massapoag Ave. Owner – Bryan Cetlin. Reinforced concrete pipe in the brush across the street from the driveway at 116 Massapoag Ave. Pipe is shown on GIS Drainage Group. Catch basin in the road.

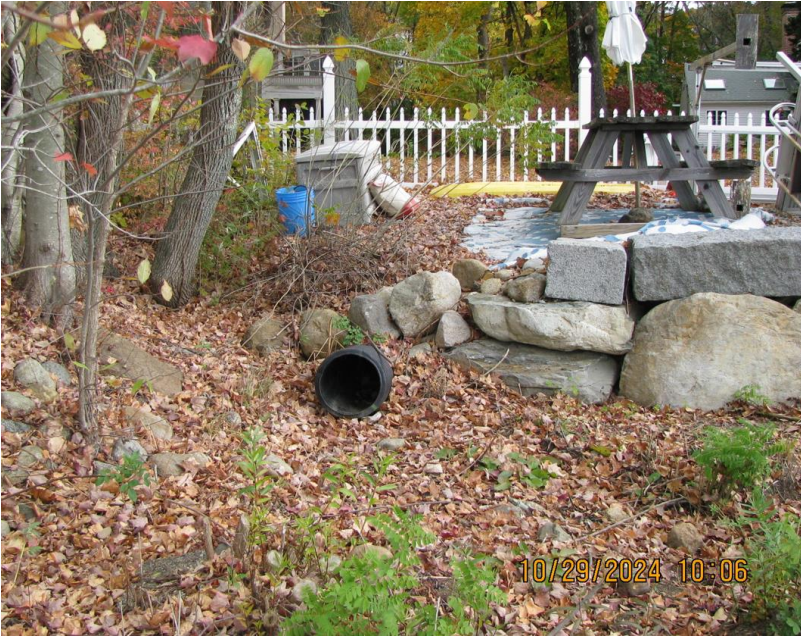
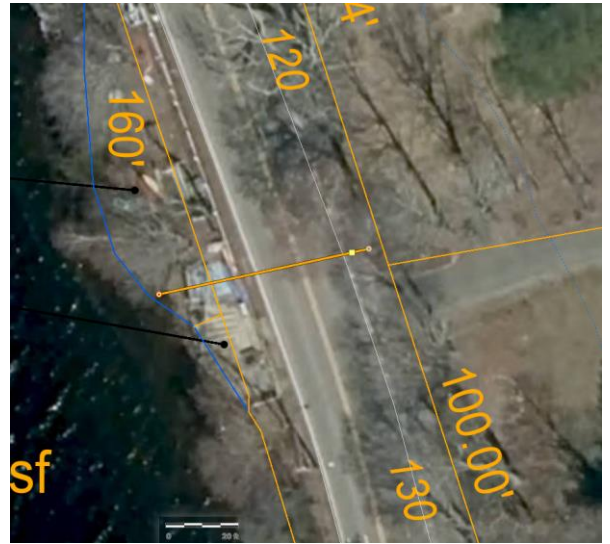
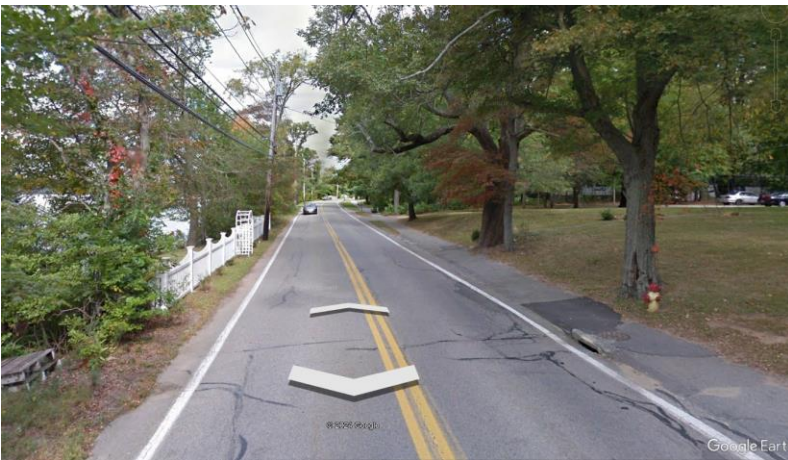
4. Parcel is 120 Massapoag Ave. Owner Edna McNeil. Pipe is shown on GIS Drainage Group, across from the driveway to 130 Massapoag Ave. No easement shown. Catch basin on roadway.

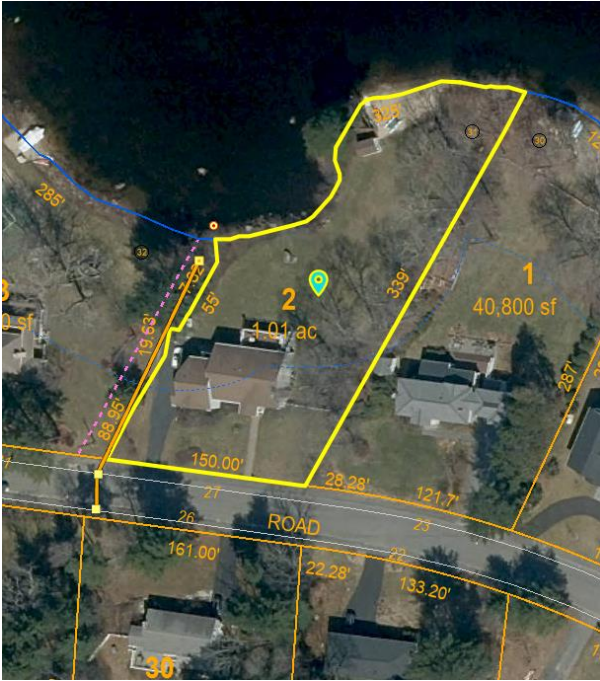
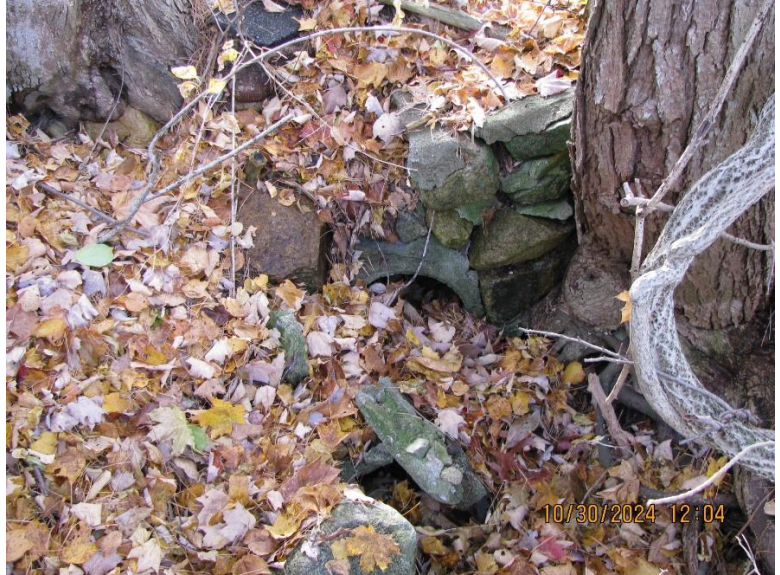
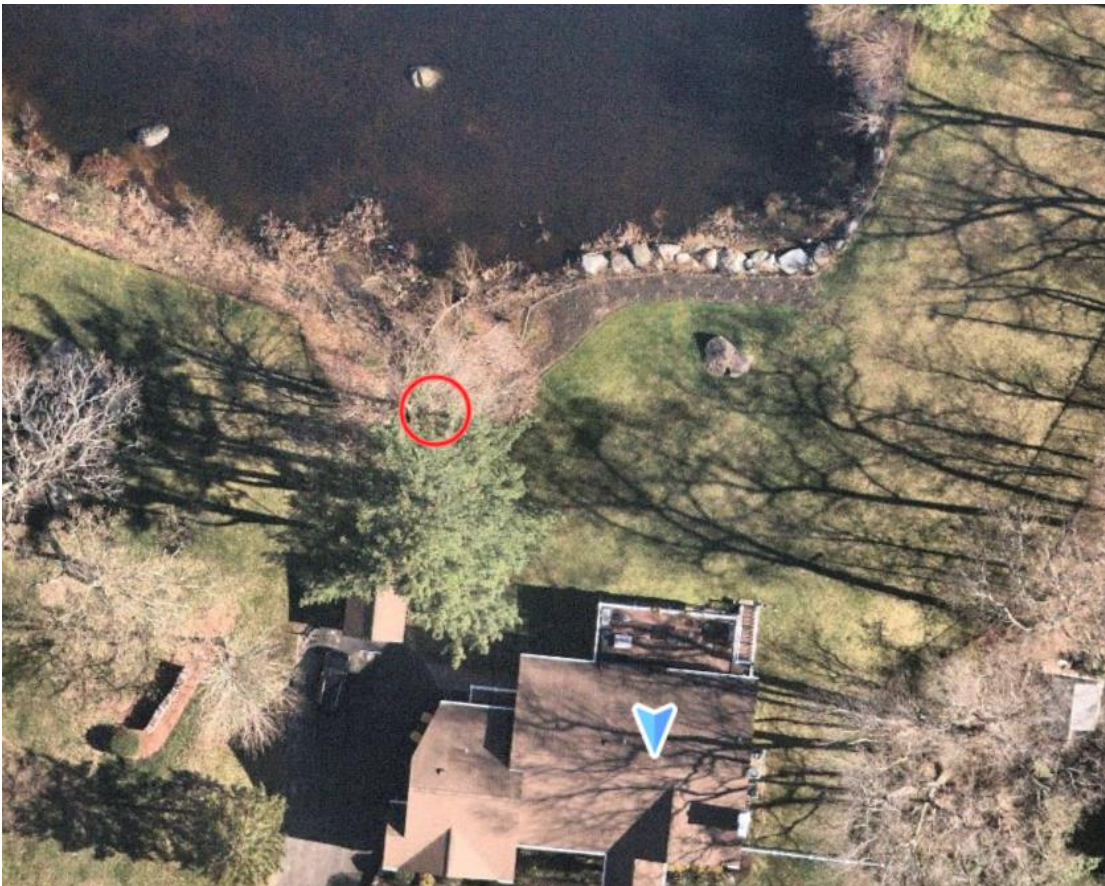
5. There is a drainage easement on 31 Livingston Road that discharges near the lake. The location is shown on the GIS Drainage Group. There is some vegetation between the outfall and the lake.

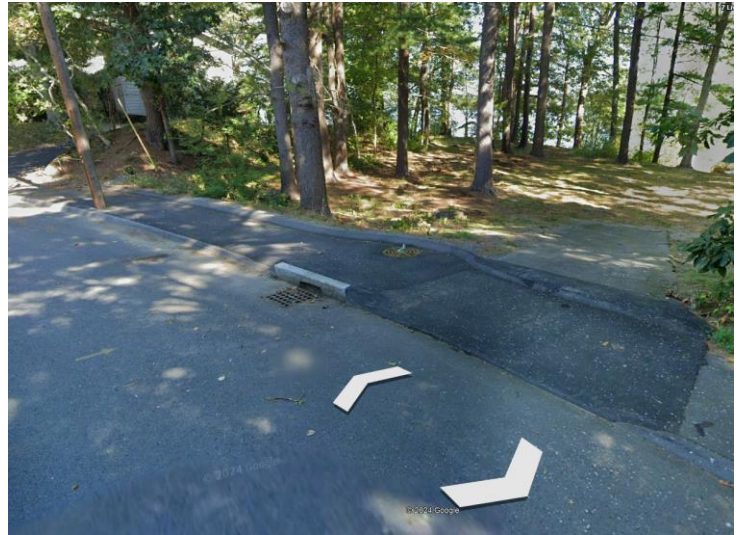
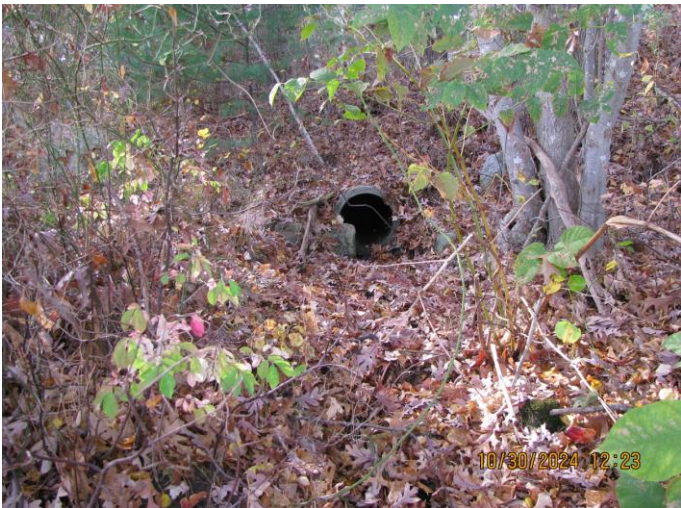
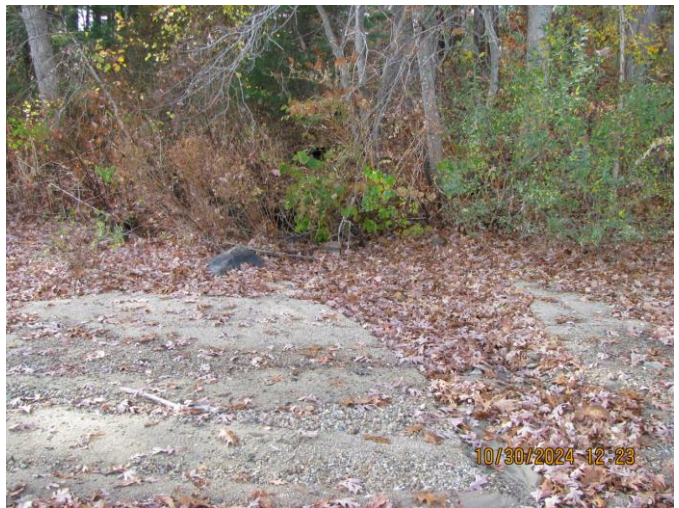
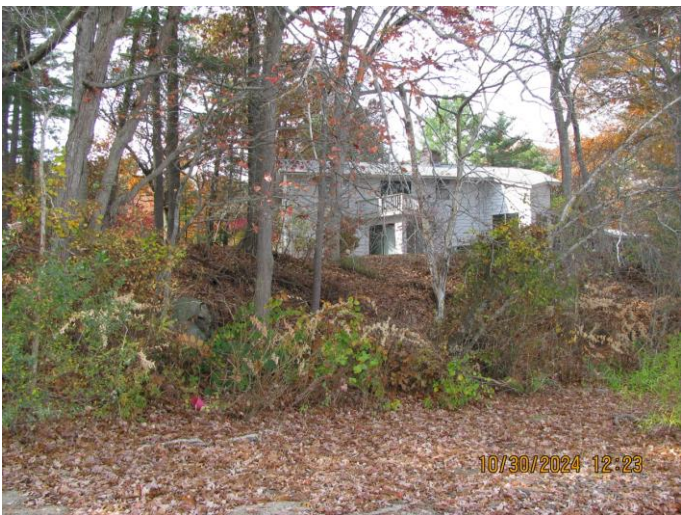
6. The parcel at 11 Livingston Road has a drainage easement that leads to an outfall. The pipe is shown on the GIS Drainage Group between 7 and 11 Livingston Road. There is a storm drain at the street. There is a good deal of erosion in the sand on the shore. We did not find an outfall between 13 and 19 Livingston Road. It may be set back away from the lake edge.

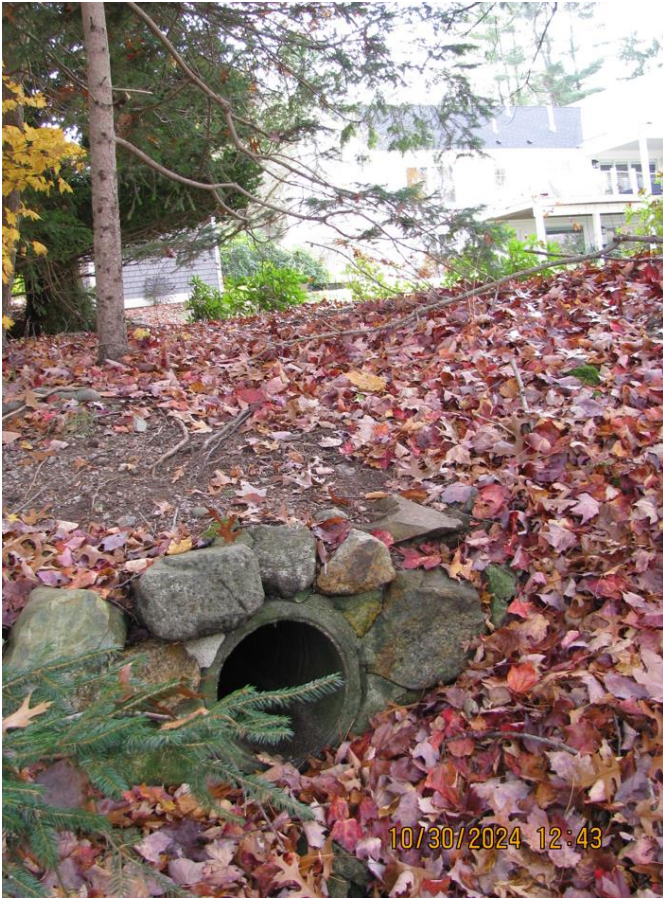
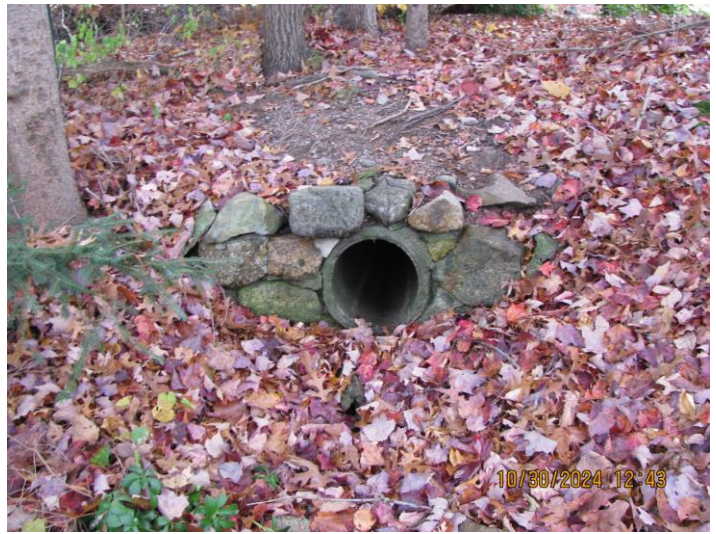
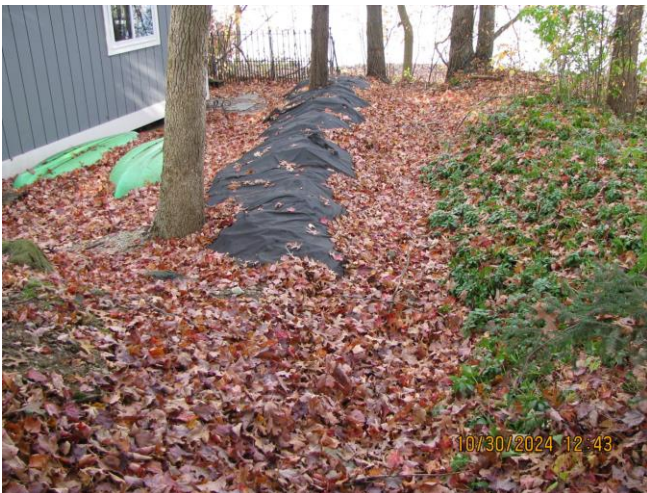
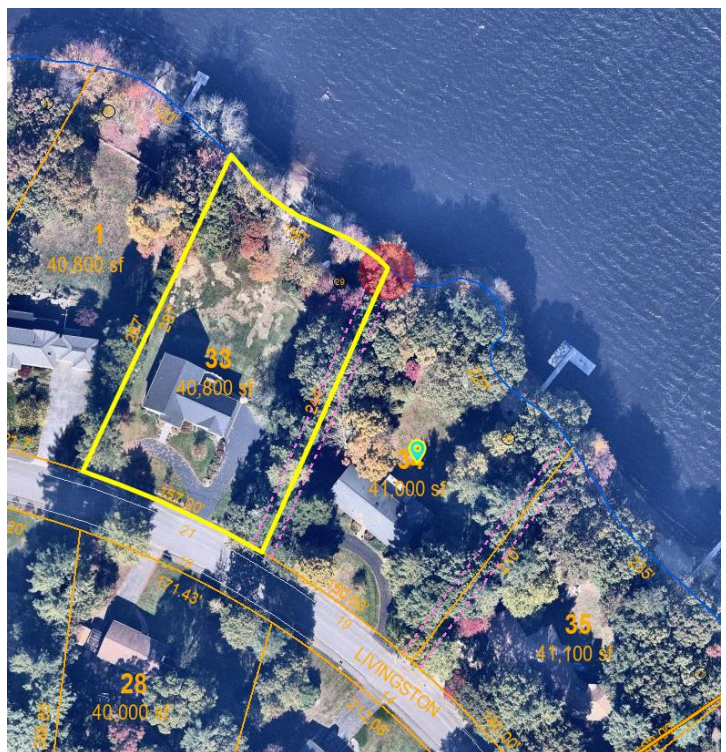
7. Between 19 and 21 Livingston Road is a drainage easement with a RCP storm drain outfall. The outfall is accessible from the street by walking between the yards or from the water's edge. This outfall is not shown on the GIS Drainage Group. The house in the back of the first image is 21 Livingston Road.

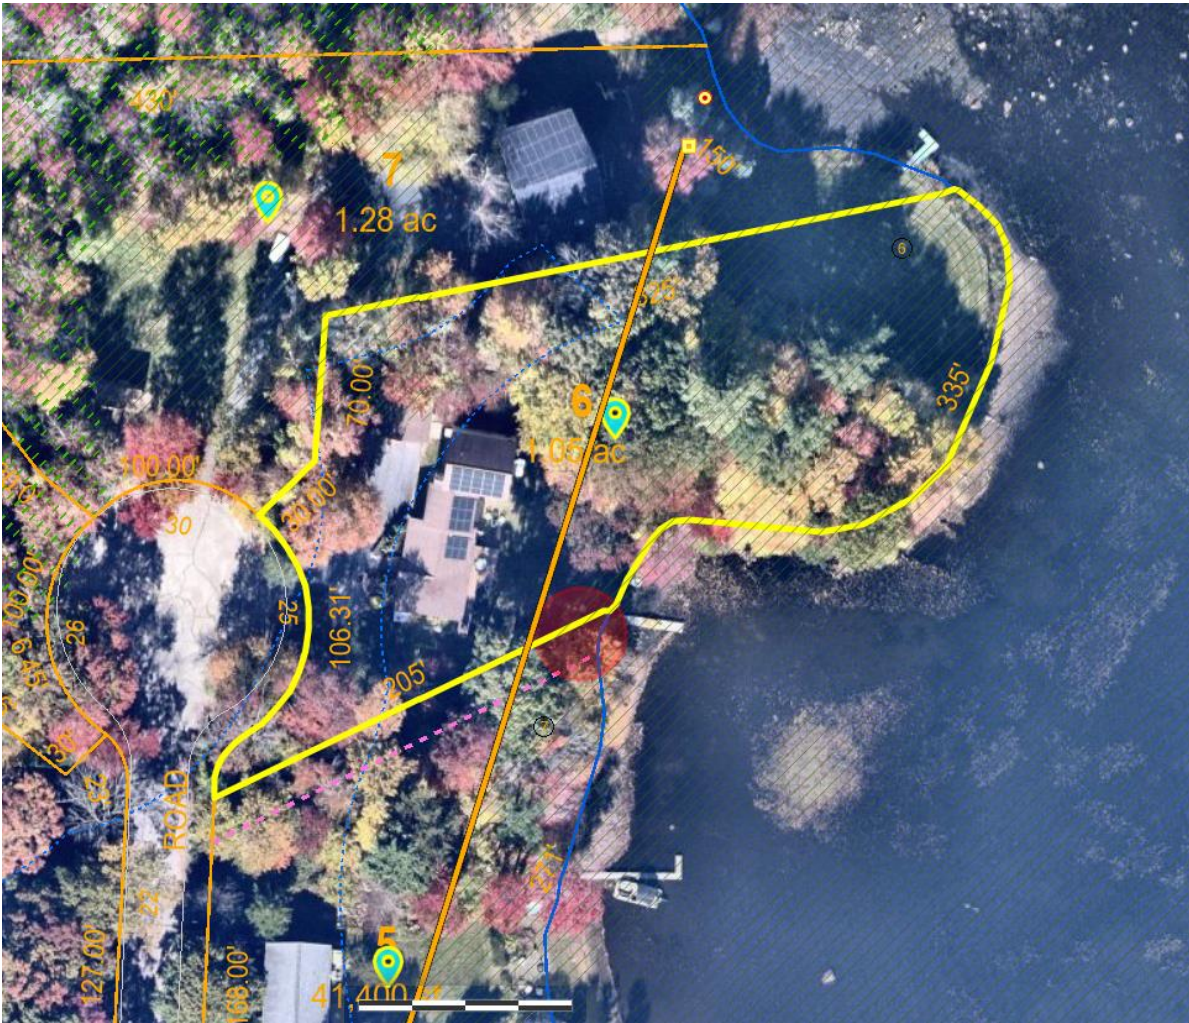
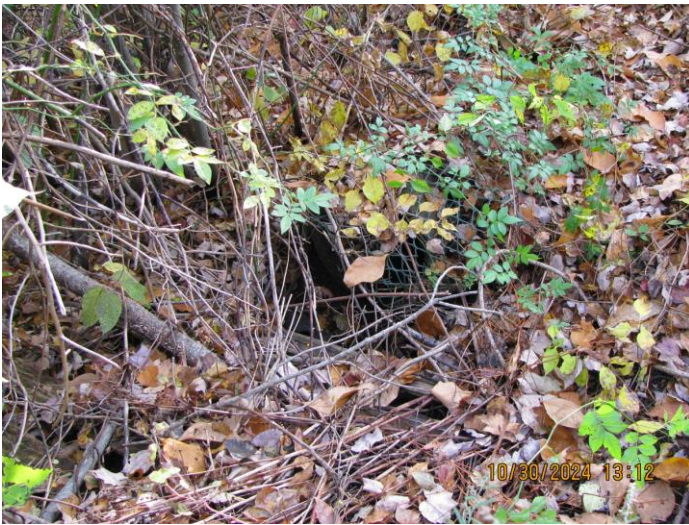
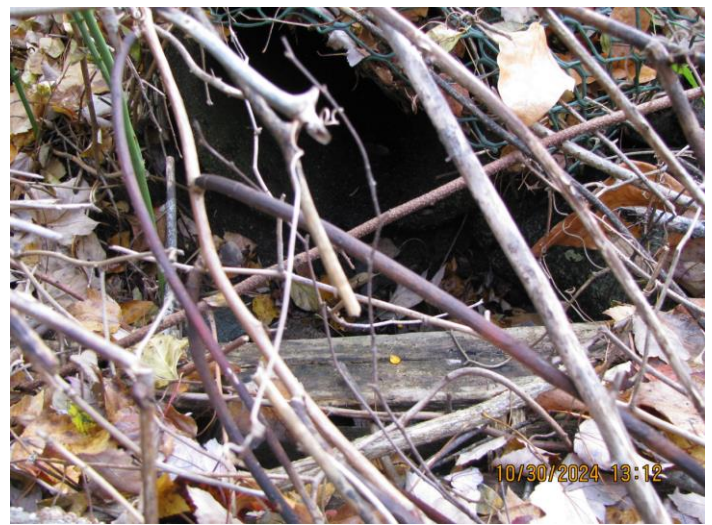
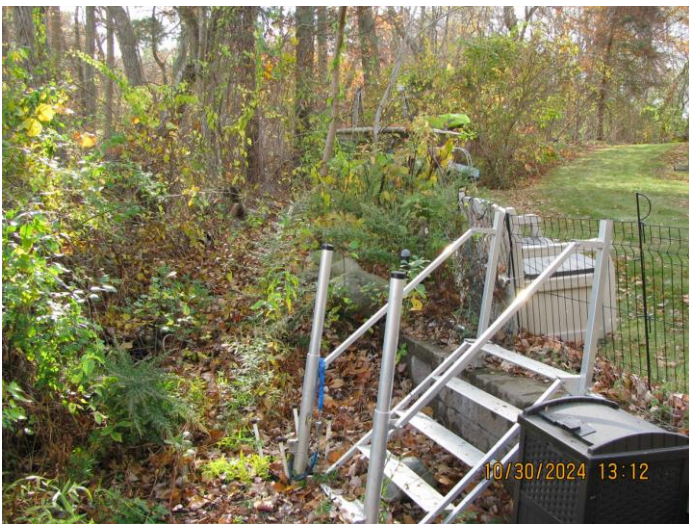
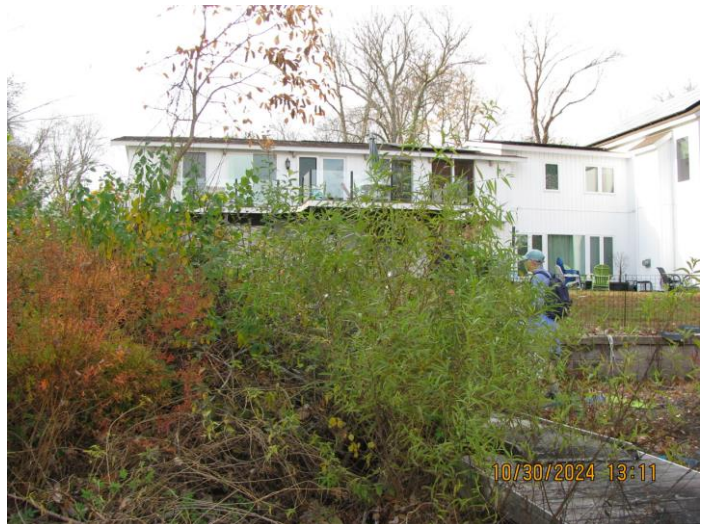
8. To the left of the dock at 25 Sturges is an outlet. The town GIS shows an outlet in a different location, but there is no indication of an outlet as shown. There is an easement that extends from Sturges Road to the outlet shown in the images below.

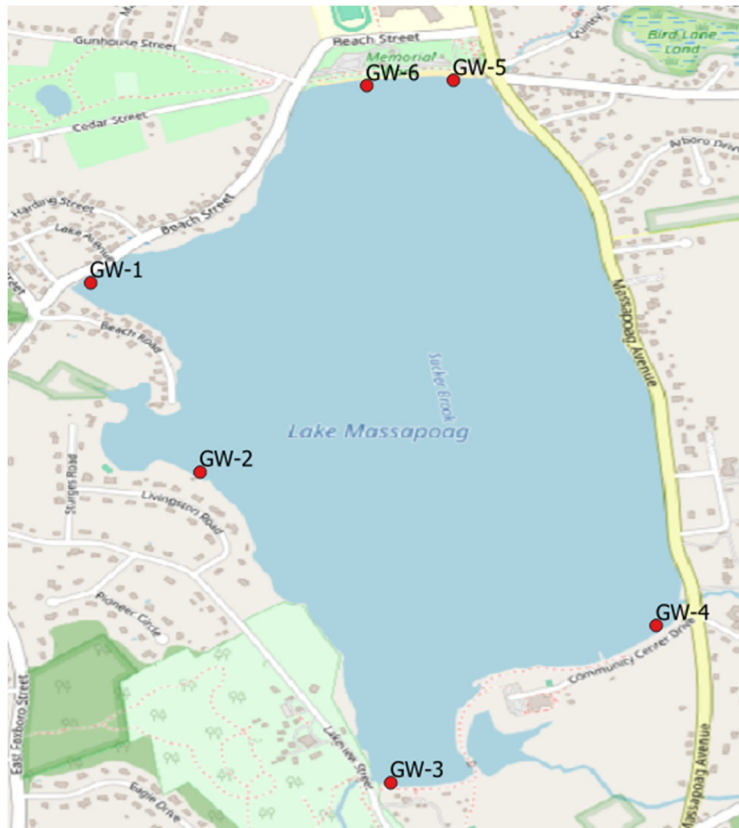
**Figure 1. Seepage Meter Locations at Lake Massapoag**

During the survey, twelve seepage meters were deployed along six key shoreline segments (i.e. two meters at each shoreline) around Lake Massapoag (Figure 1) to estimate the rate of in- or out-seepage. These study shorelines were distributed evenly around the lake, given the physical constraints of the shoreline, to ensure characterization of overall seepage conditions. Due to rocky conditions, seepage meters were not able to be installed on the eastern shoreline of the lake along Massapoag Avenue, so that shoreline segment was moved to capture the eastern end of Memorial Beach. Three seepage meters were observed

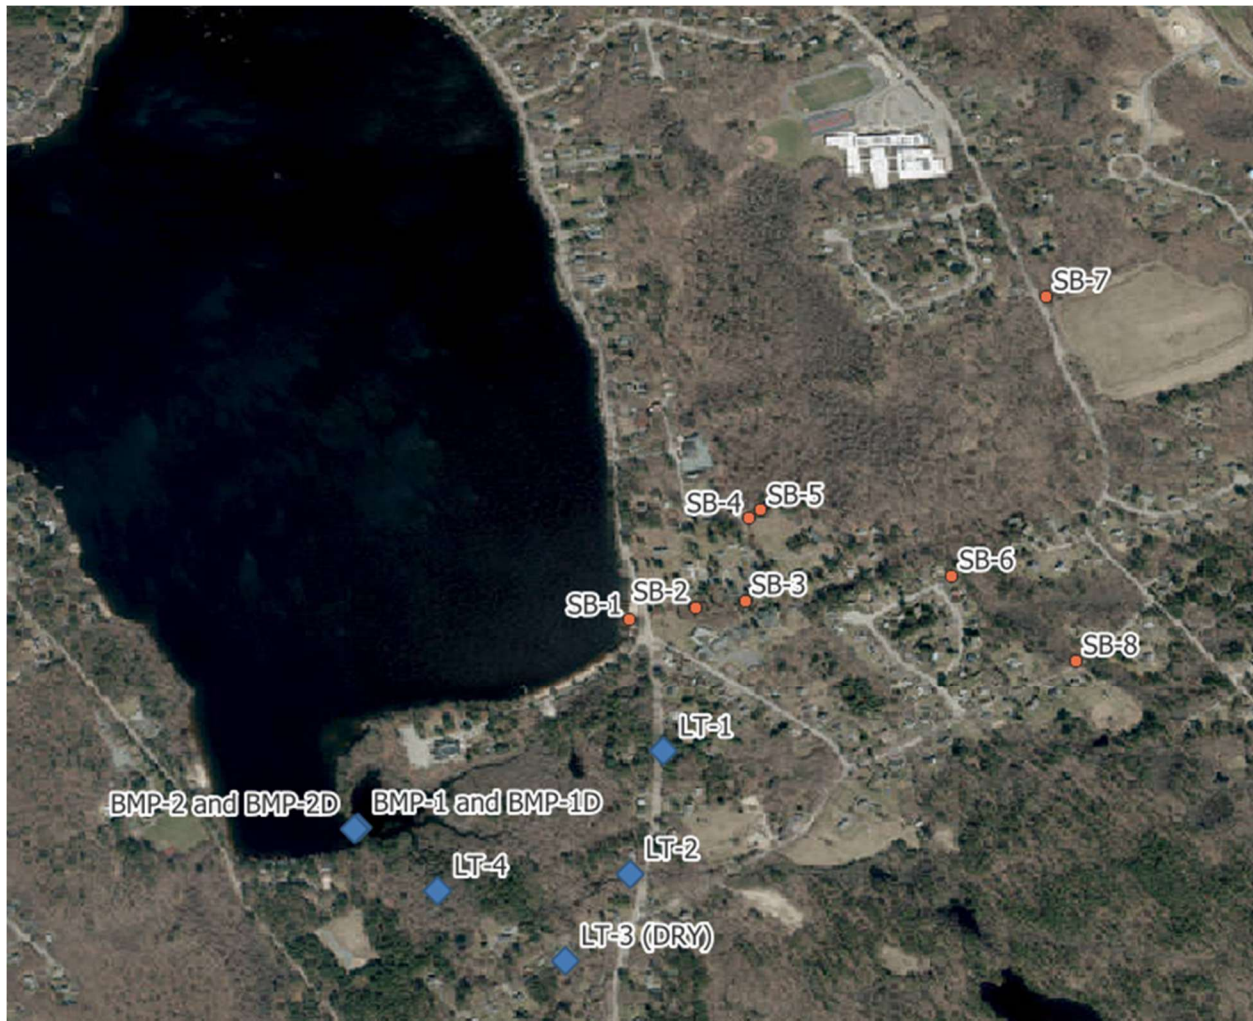
Figure 1. Sucker Brook (orange) and Lagoon (blue) Sampling Locations.
