DEERFIELD RIVER WATERSHED 2000 WATER QUALITY ASSESSMENT REPORT

DEERFIELD RIVER WATERSHED
2000 WATER QUALITY ASSESSMENT REPORT

33-AC-1

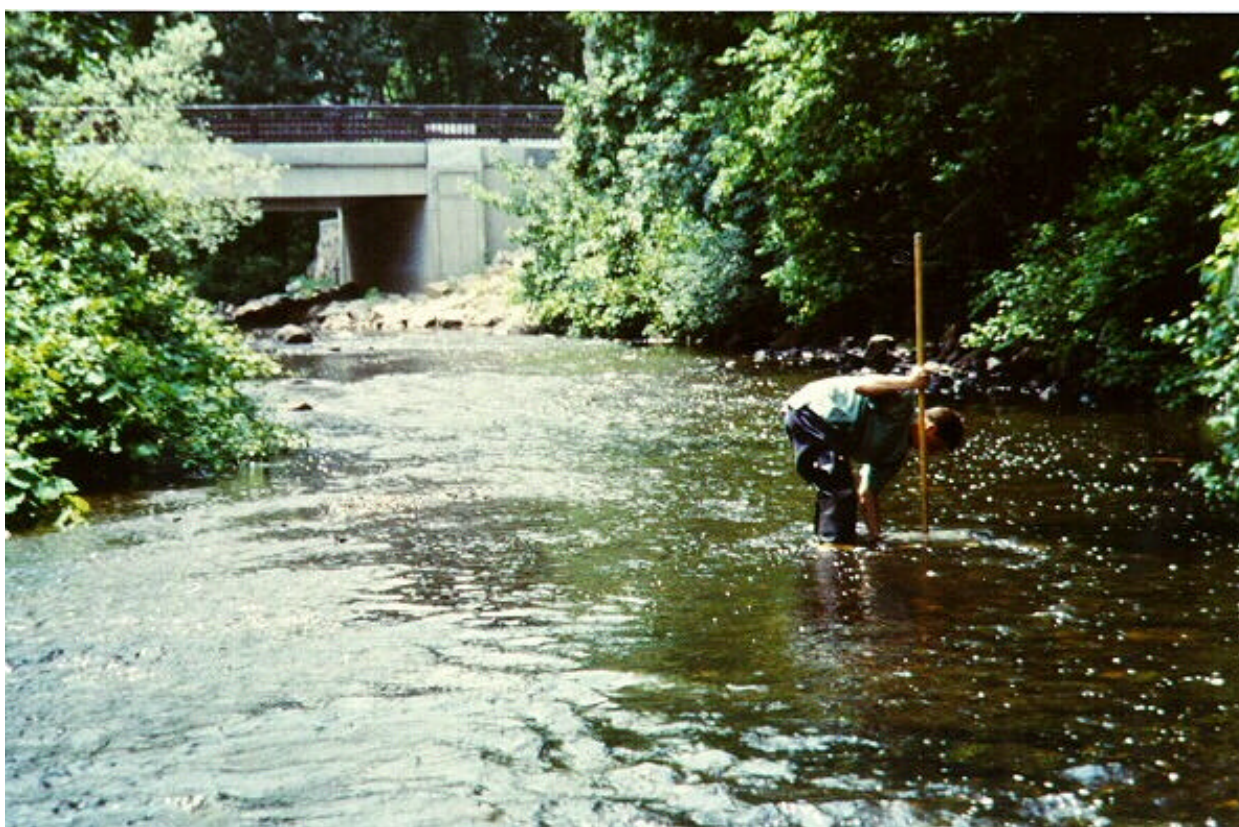
Figure B2. MA DEP/DWM biologist collecting macroinvertebrates using the “kick-sampling” technique.
