HOUSATONIC RIVER WATERSHED 2002 WATER QUALITY ASSESSMENT REPORT

HOUSATONIC RIVER WATERSHED
2002 WATER QUALITY ASSESSMENT REPORT

Prepared by:
Jamie W. Carr and Laurie E. Kennedy
Department of Environmental Protection
Division of Watershed Management

21-AC-4

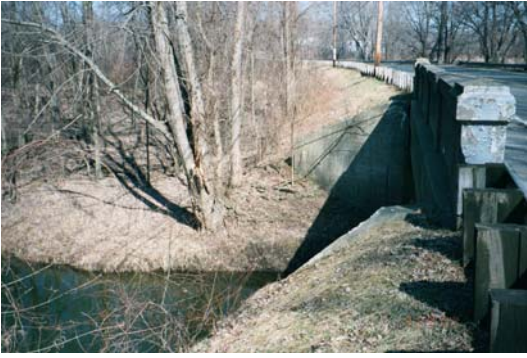
Figure 3: Hubbard Brook (MA21-15) station at Rt. 7 bridge in Sheffield, MA.

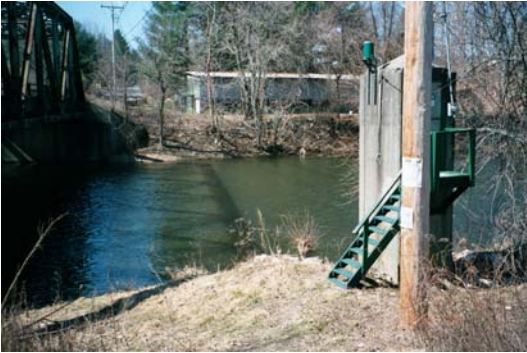
Figure 4: Housatonic River (MA21-20) station @ Division Street, Great Barrington, MA.

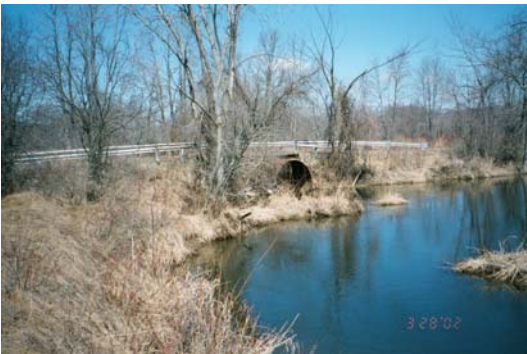
Figure 5: Hop Brook (MA21-TBD) station at Meadow St. in Lee, MA.

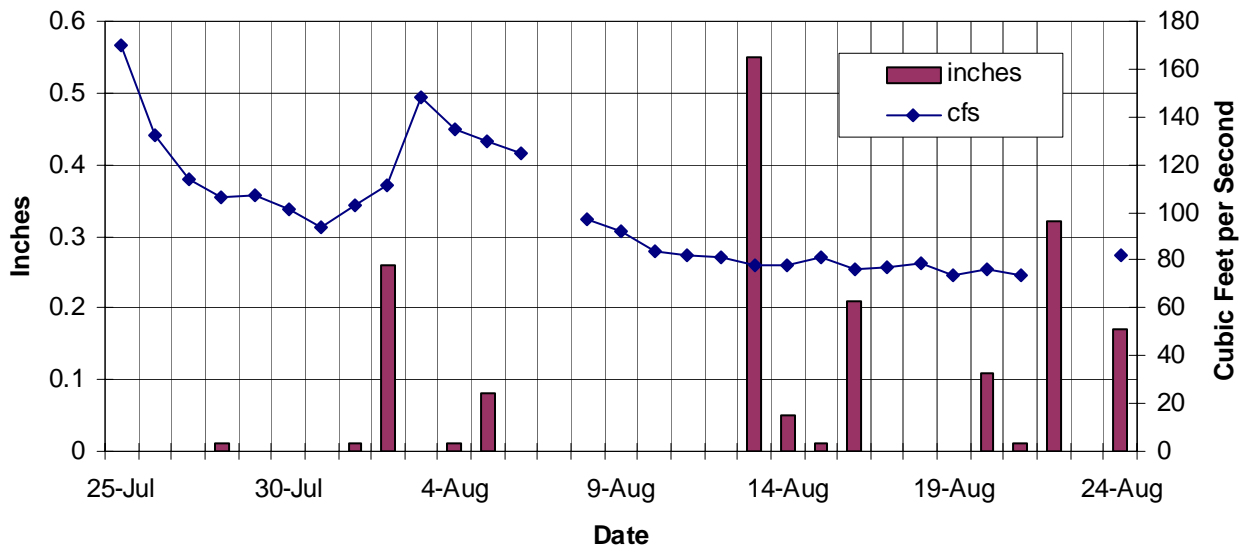
Figure 7: Representative river flow and precipitation data in the area

The closest known precipitation station, located in Pittsfield, MA, and is more than 20 miles upstream from the Division Street sensor station. In general, daily rainfall amounts in the summer of 2002 were low and localized. There are several impoundments between the rainfall gauge and the most upstream sensor station. The rainfall data shows very little relationship to the stream flow at the gage. For example, the 0.55" rain event recorded in Pittsfield on August 13, 2002 shows no impact upon the gage reading. This may be because of the several impoundments between the rainfall event and the gage.

Precipitation (Pittsfield - DEM) in Inches and Discharge (USGS gage 01197500) in Cubic Feet per Second at Division Street, Great Barrington, MA

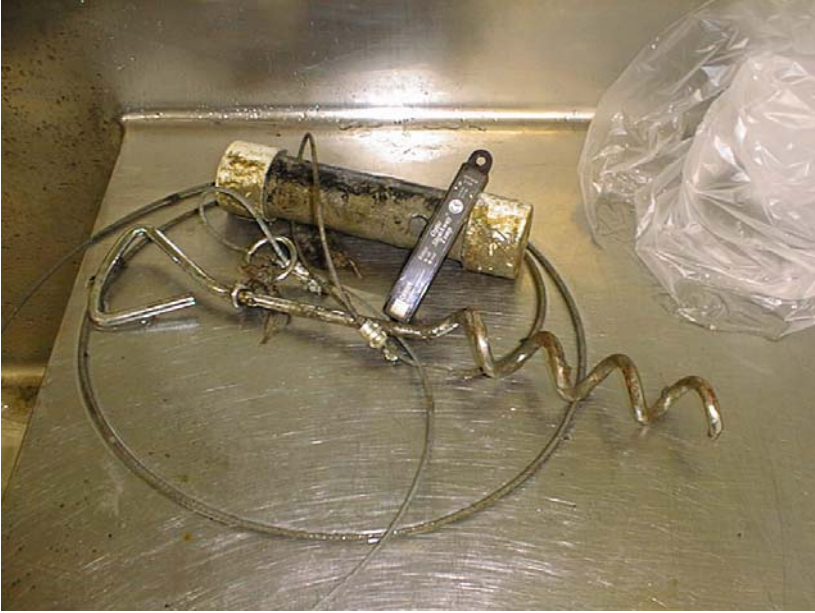
Appendix A: Temperature Logging Equipment

Stowaway sensor, plastic tube and cable/anchoring assembly shown.

Optic Stowaway Temp Specifications: (as provided by Onset Computer Corp.)

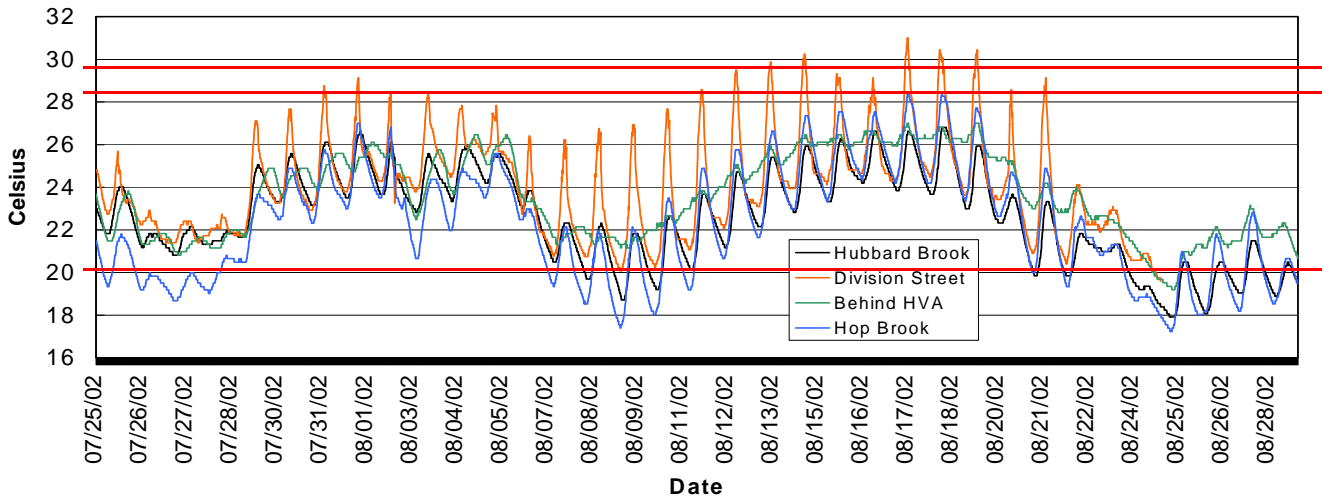
Continuous Water Temperature at Hubbard Brook

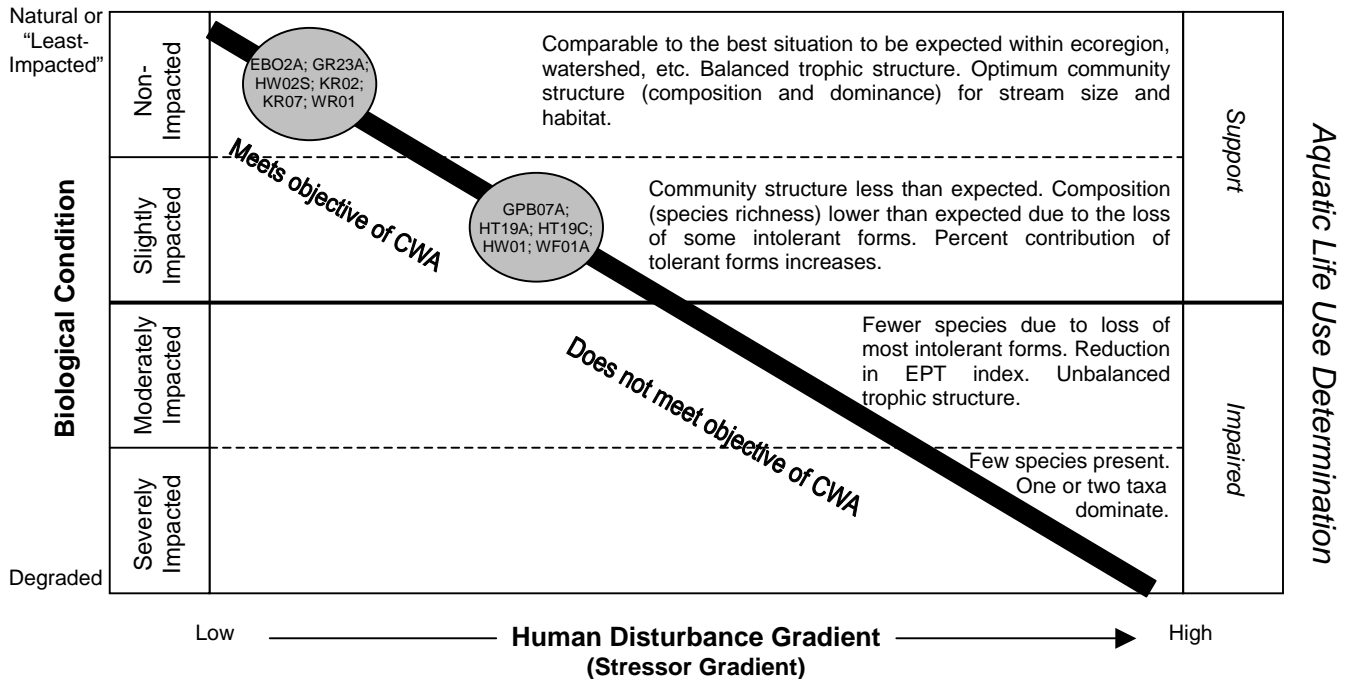
The schematic below (Figure 5) is based on a proposed conceptual model that predicts the response of aquatic communities to increasing human disturbance. It incorporates both the biological condition impact categories outlined in the RBPIII biological assessment methodology currently used by MA DEP and the Tiered Aquatic Life Use (TALU) conceptual model developed by the US EPA and refined by various state environmental agencies (US EPA 2003). The model summarizes the main attributes of an aquatic community (in this case the benthic macroinvertebrate community **only**) that can be expected at each level of the biological condition category, and how these metric-based bioassessments can then be used to make aquatic life use determinations as part of the 305(b) reporting process. Minimally or non-impacted aquatic communities, such as those encountered at all Housatonic stations, *support* the Massachusetts SWQS designated *Aquatic Life* use in addition to meeting the objective of the Clean Water Act (CWA), which is to restore and maintain the chemical, physical, and biological integrity of the Nation’s waters (Environmental Law Reporter 1988). No benthic communities assessed in this study failed to support the *Aquatic Life* use goal of the CWA. This is not to say that stations achieving a designation of *non-impacted* should be considered pristine. There may be stressors affecting water quality, aesthetics, and other biotic communities that have little impact upon the benthic community.

Figure 5. Schematic of the predictive response of aquatic communities to increasing human disturbance. Included is the performance (Biological Condition and Aquatic Life Use determinations) of the Housatonic River watershed 2002 biomonitoring stations along the Human Disturbance Gradient. NOTE: All reference stations (EBO1B, HT19E, KR11, WB01) are considered to represent the “best attainable” conditions and to be supportive of the *Aquatic Life* use.
