# **MERRIMACK RIVER WATERSHED 2004 WATER QUALITY ASSESSMENT REPORT**

MERRIMACK RIVER WATERSHED  
2004-2009 WATER QUALITY ASSESSMENT REPORT

Report Number:  
84-AC-2

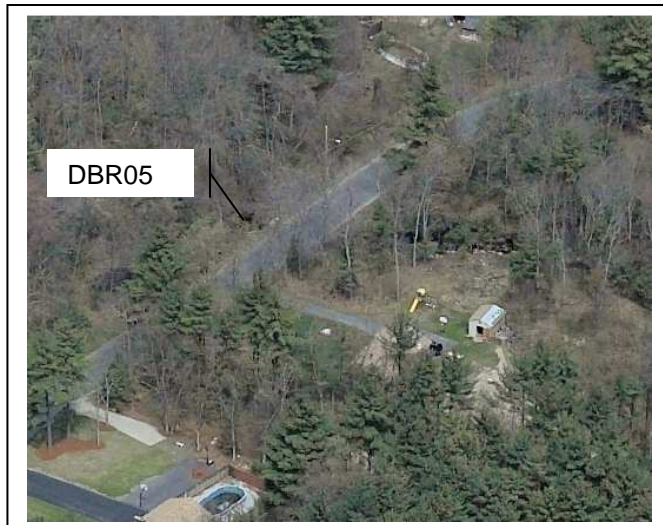
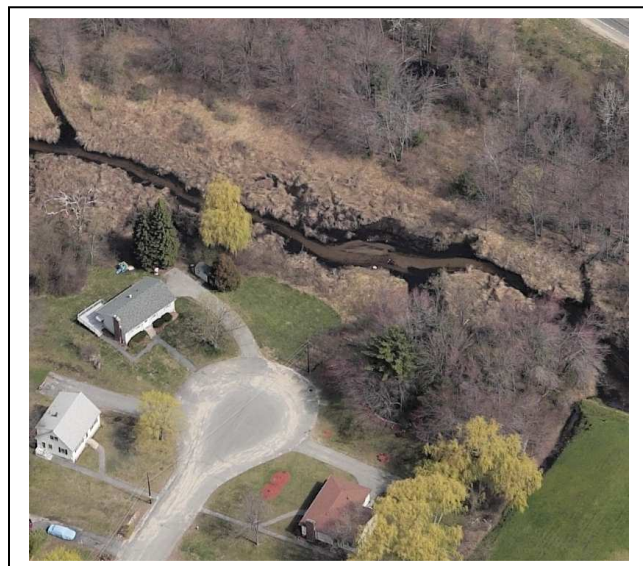
View off end of Marguerite Road, Chelmsford  
(downstream from Swains Pond)

Sedimentation is a major problem in the lower portion of this stream. Sampling crews were frequently stopped by civilians and told that sand from the Route 3 construction was washing into the brook (Fiorentino personal communication 15 December 2005). Fish population crews gave this reach a score of 10 out of 20 due to sedimentation (Maietta 2004). Pictometry images reviewed in the preparation of this technical memorandum show that the brook is channelized downstream from Swains Pond and large sand bars have filled in the center of the channel (see inset to the left). An unnamed tributary flows under Route 3 and discharges to Deep Brook just downstream from the sampling station. A quarry is located to the west of Route 3 at the headwaters to this unnamed tributary.
